Tree Preservation Report

TREE PRESERVATION REPORT FOR PENINSULA HEIGHTS

2655, 2755, 2800 & 2988 Campus Drive, San Mateo

February 6, 2020 (Revised 5/21/20 per plan check comments & retaining wall changes)

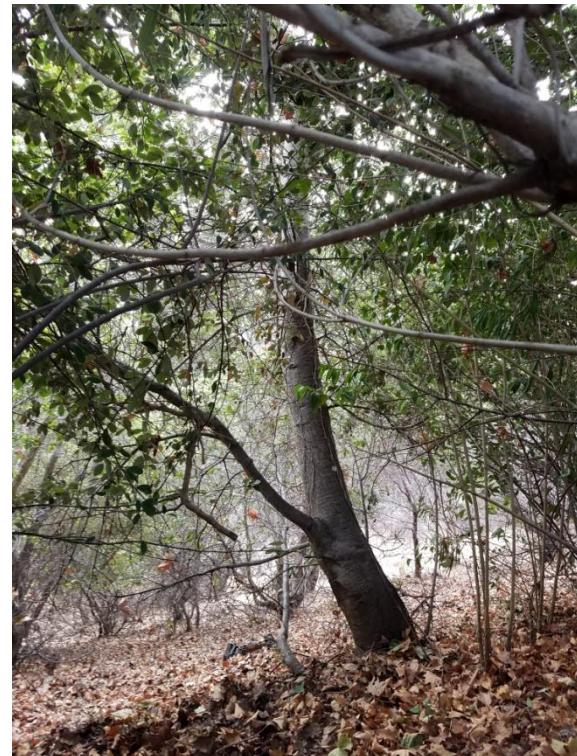
Figure 2. Oak #11 was hidden in brush below a hedge. Although it was not surveyed, its precise location is not crucial.

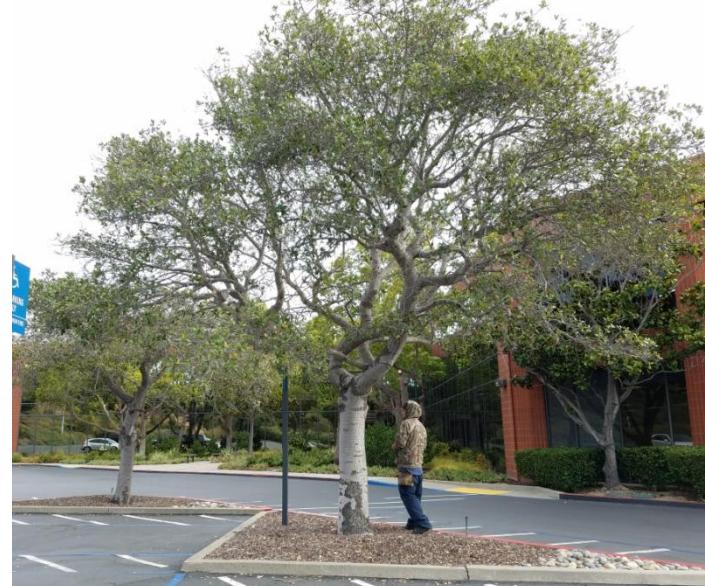
Figure 3. Trees in parking lot planters are generally in poor shape due to limited rooting space (oaks #43 & 44 above). The camphors and magnolias by the building in the background were in similar condition.

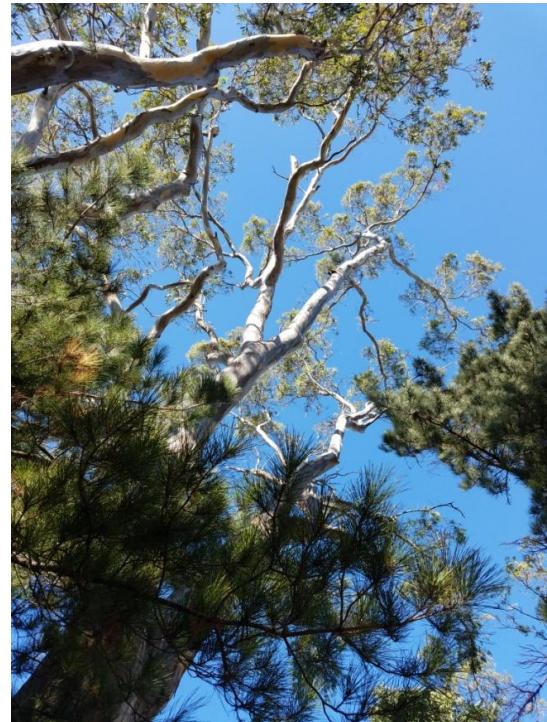
Figure 4. Eucalyptus #354 is an example of an off-site tree that is in decline. Although it is not an ideal candidate for preservation, I provided minimum clearances to reduce root encroachment. It is likely to continue to decline regardless of construction.
