California Tree and Landscape Consulting, Inc.

May 25, 2022

RE: AMENDED ARBORIST REPORT FOR HAYWARD PARK STATION COMPLEX DEVELOPMENT, SAN MATEO, CA

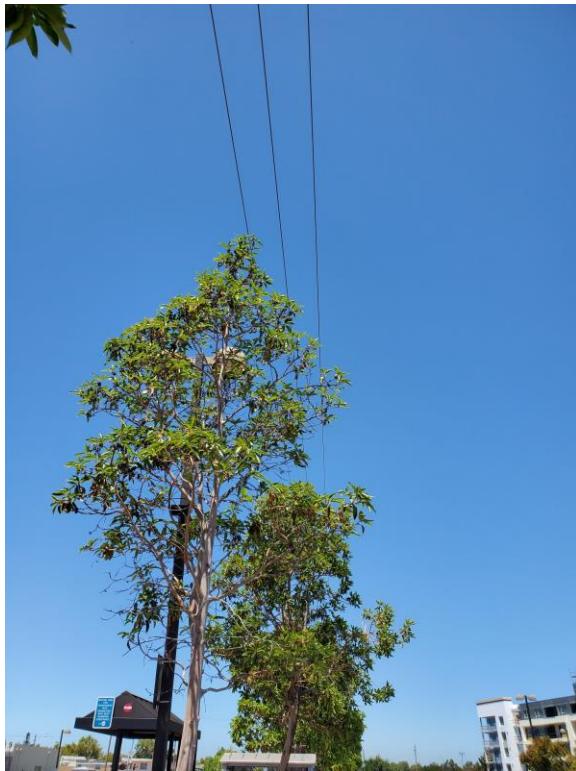
There was a row of Brisbane Box trees growing in a planting space along the westerly side of the property and the east side of the train station platform and fence. The planter width ranged from approximately 4.5 feet to 6.5 feet. All of the Brisbane Box trees along the railroad tracks were growing under electrical overhead power lines. On the south side of the property where the street bends south parallel to the railroad tracks there were trees planted that may be off property following the lot line on the plans. There were bamboo growing on the east side of the fence apparently off property and some foliage extended into the subject property by up to 5 feet.

Most of the trees were found to be in fair or good condition at the time of the inspection with only one tree #8966 being in poor condition. The longevity of the trees is low as most of the upright Brisbane Box trees were growing under power lines and will need to be reduced by pruning for wire clearance. Most of the trees appeared to be planted in a confining circular root barriers around the root ball which will limit the root growth and root structure, and may limit the mature trunk size as the trees grow larger.

Brisbane Box trees under power lines along railroad tracks

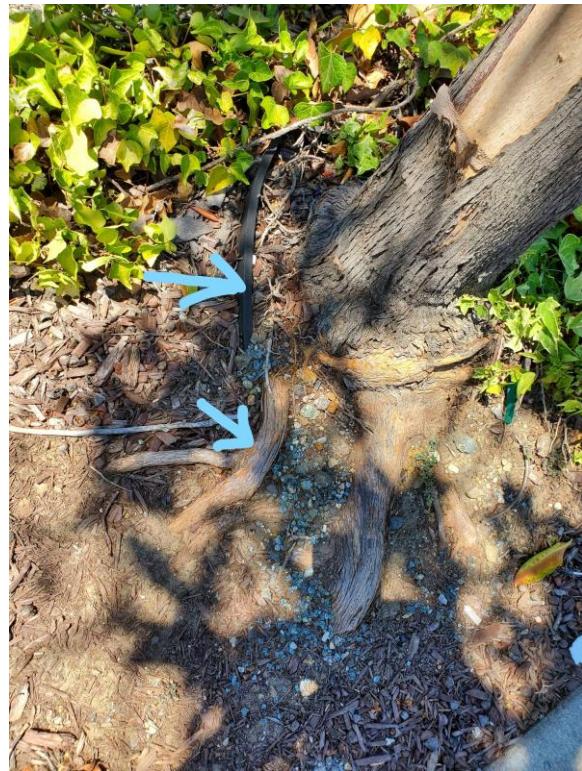
barriers stuck up above the soil and some were buried beneath the soil and evident from soil moved away. A few trees had surface roots that had grown over the barrier and some of the barriers had failed with roots growing through the barrier material.

Root barrier and roots grown over barrier

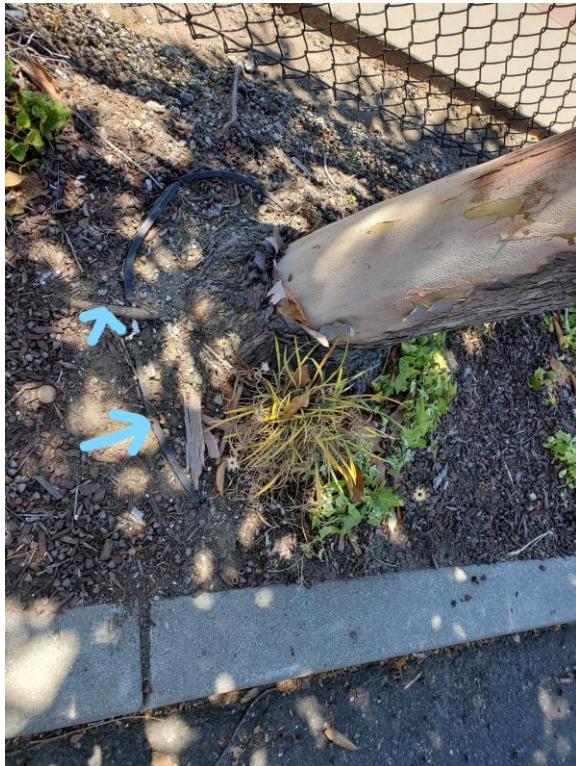
Root barrier and roots grown over barrier

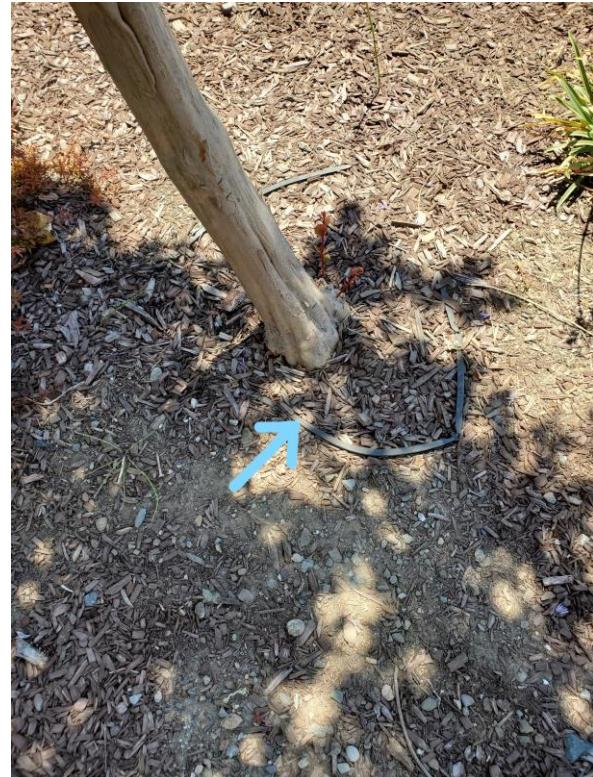
Root barrier and roots grown over barrier
