## MEMORANDUM

SUBJECT: Marina Lagoon PS – Pump Rehab Document Review

DATE: May 4, 2023

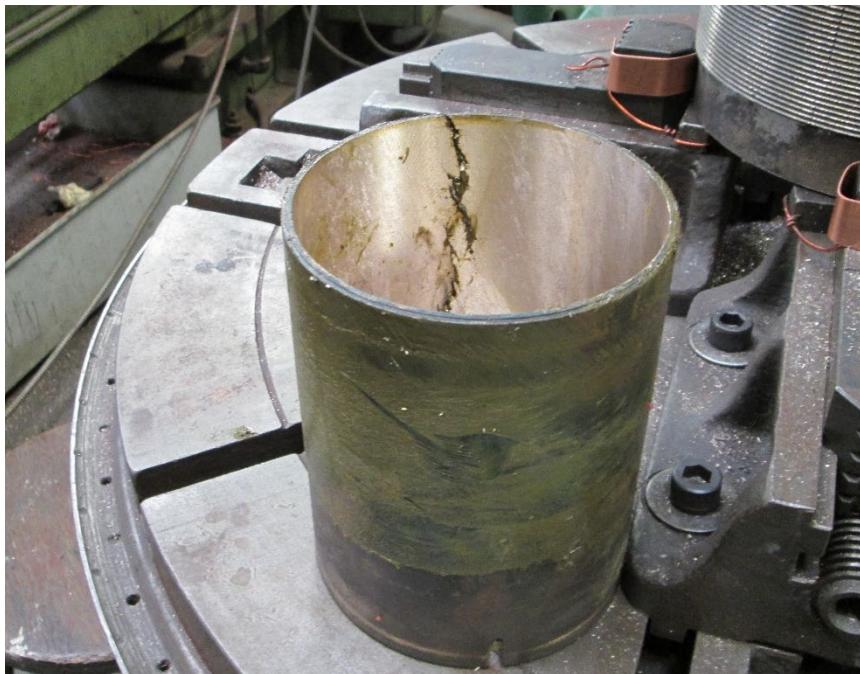
Pump shaft bearing with longitudinal crack visible.

Damaged shaft bearing

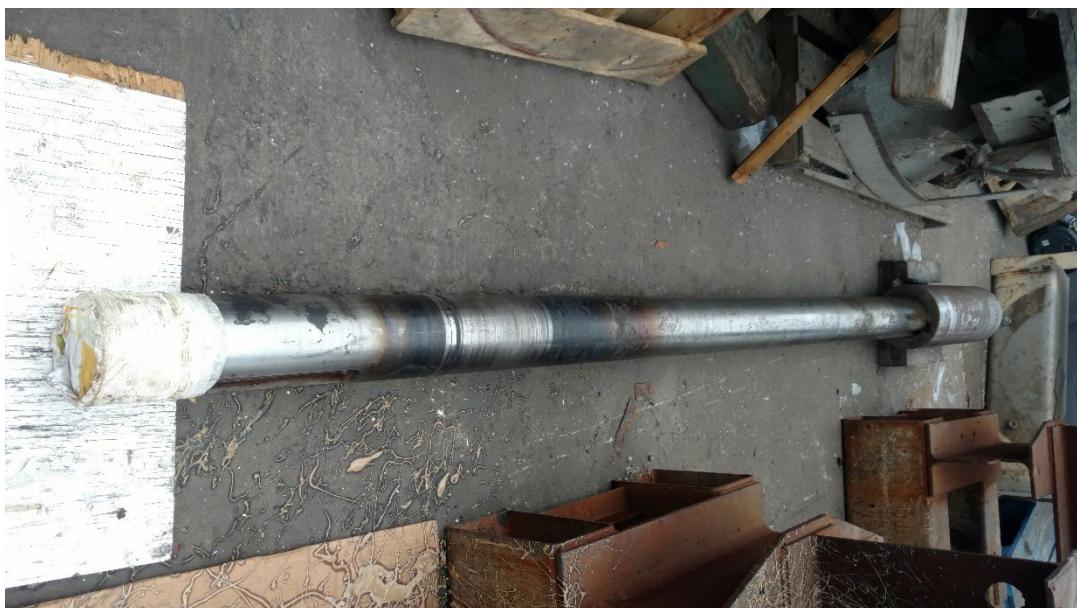
Significant discoloration of upper pump shaft at packing box bearing location (likely due to high heat), grooves visible in shaft at bearing location.

Pump shaft with heat discoloration

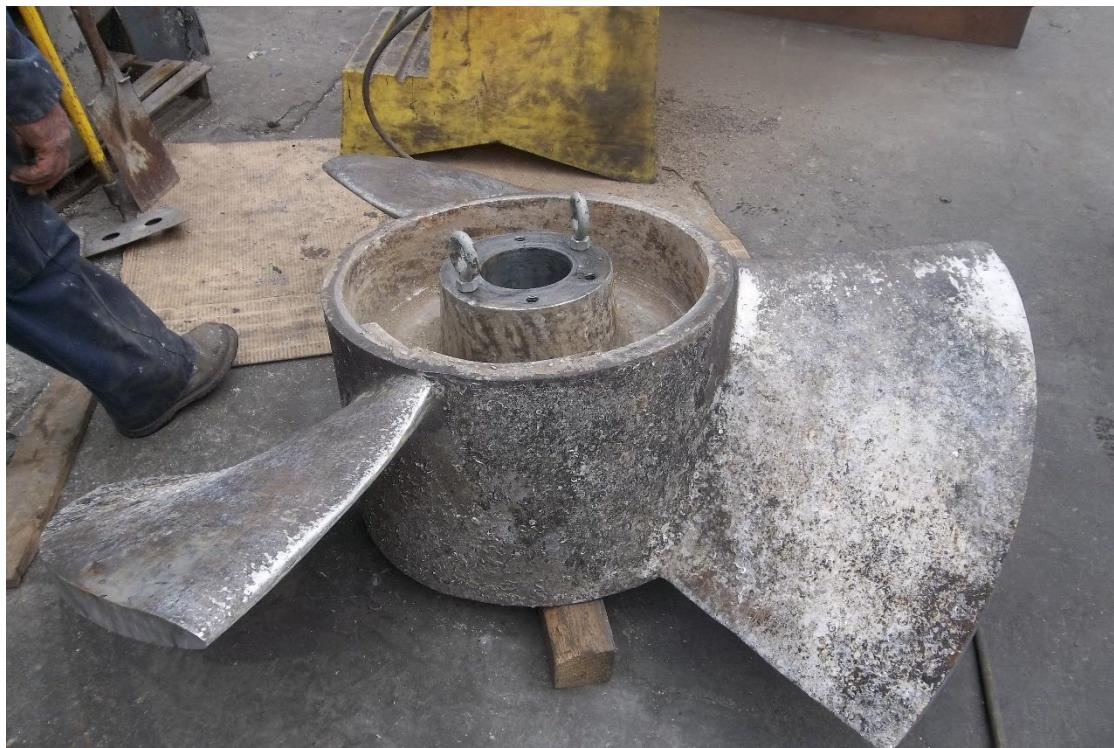
Some leading edge and propeller face wear, but not substantial.

Propeller

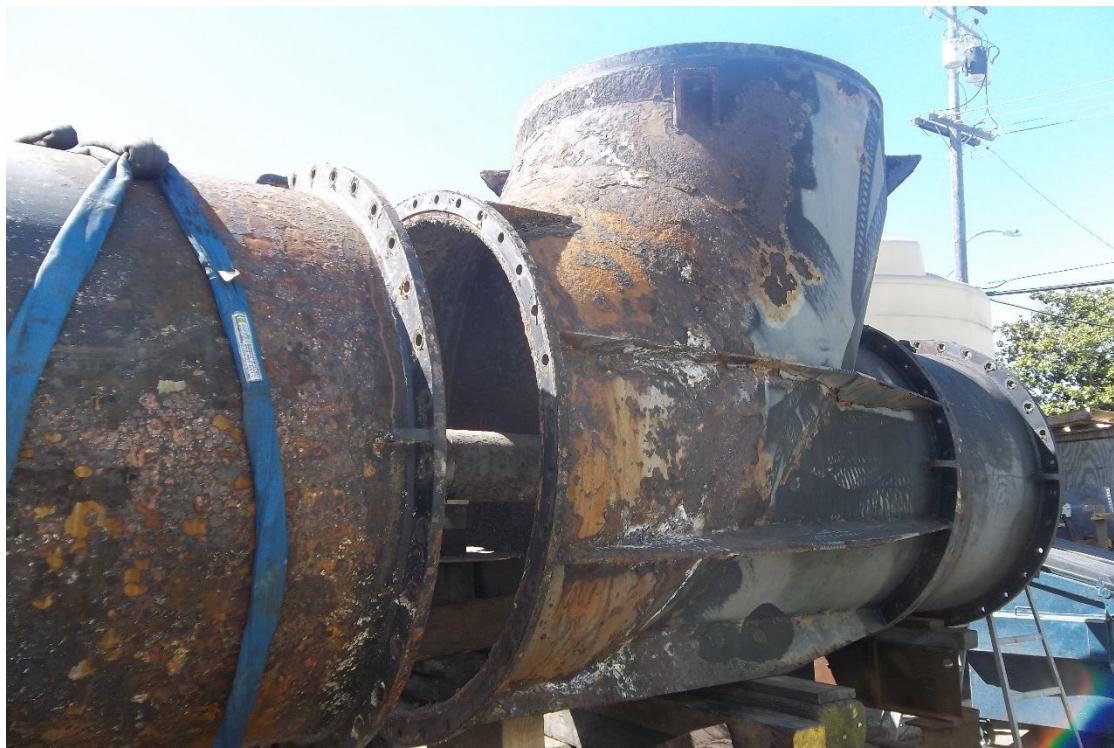
Corrosion of interior and exterior steel pump body is apparent, pitting of surface visible in multiple locations.

Pump discharge elbow w/ corrosion

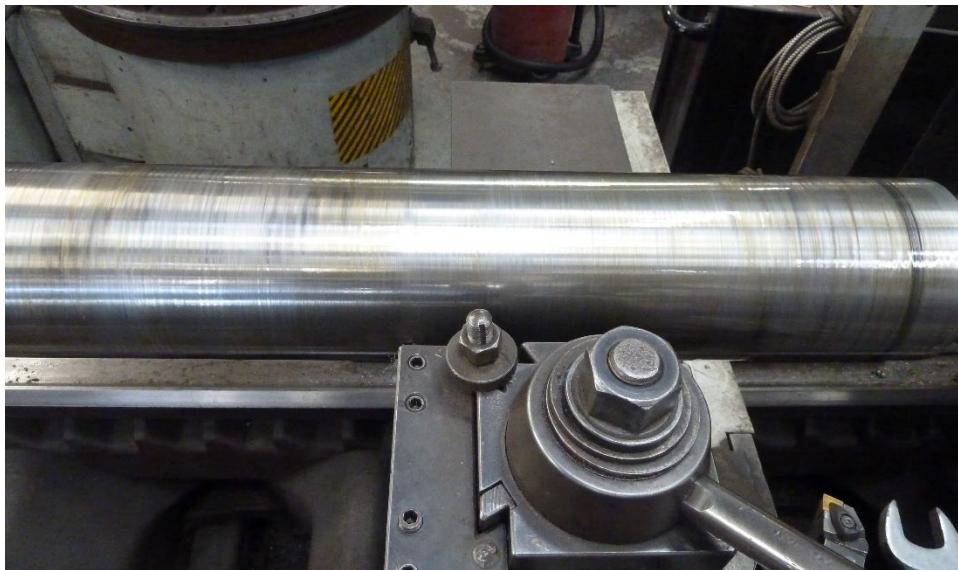
Machining of pump shaft to remove bearing grooves

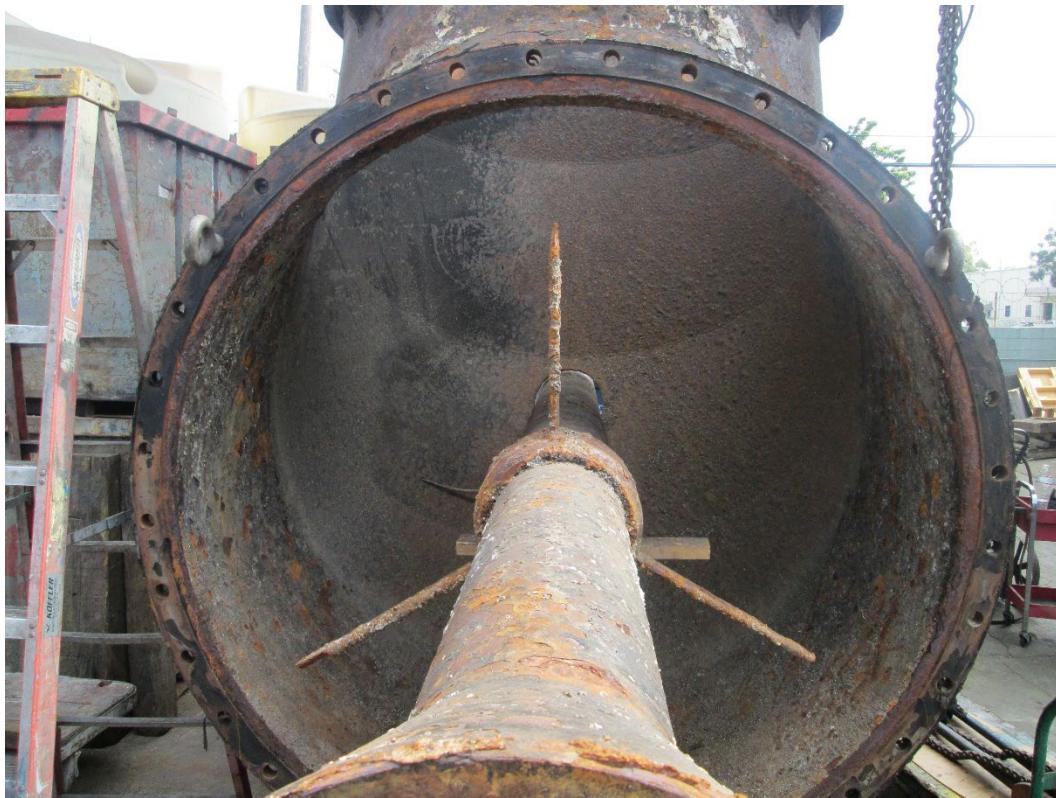
Shaft enclosure tube stabilizer spider corroded and disconnected from pump body.

Pump discharge elbow with stabilizing spider and shaft enclosure tube

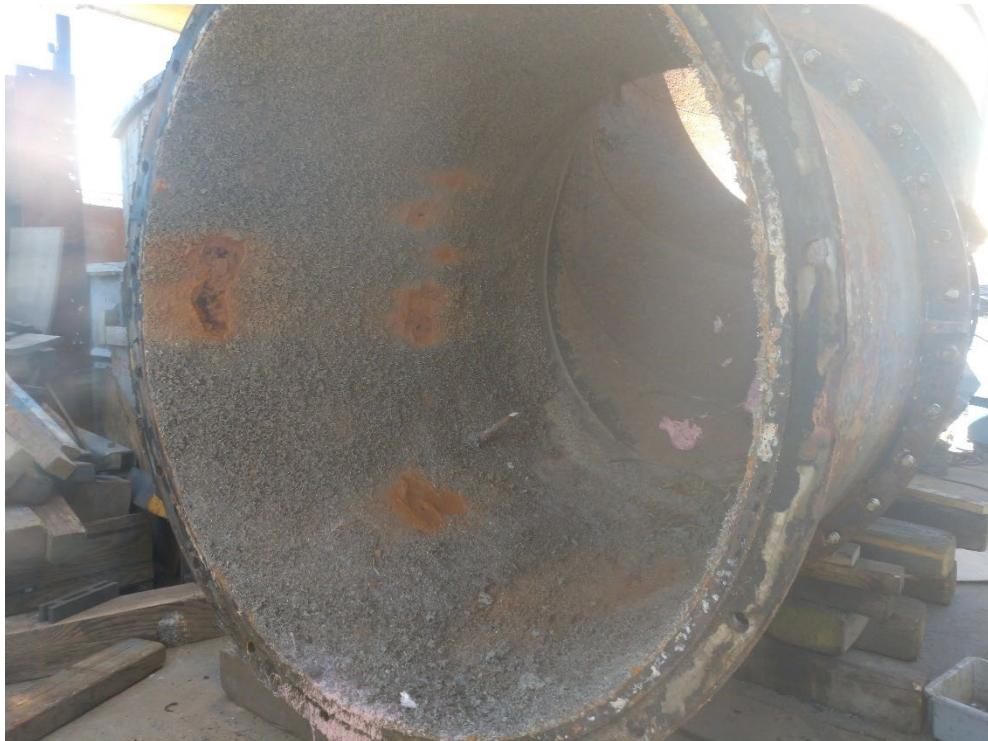
Corrosion of interior and exterior steel pump body is apparent, pitting of surface visible in multiple locations. Several locations of deep pitting and holes present.

Pump discharge elbow w/ visible corrosion (full penetration)

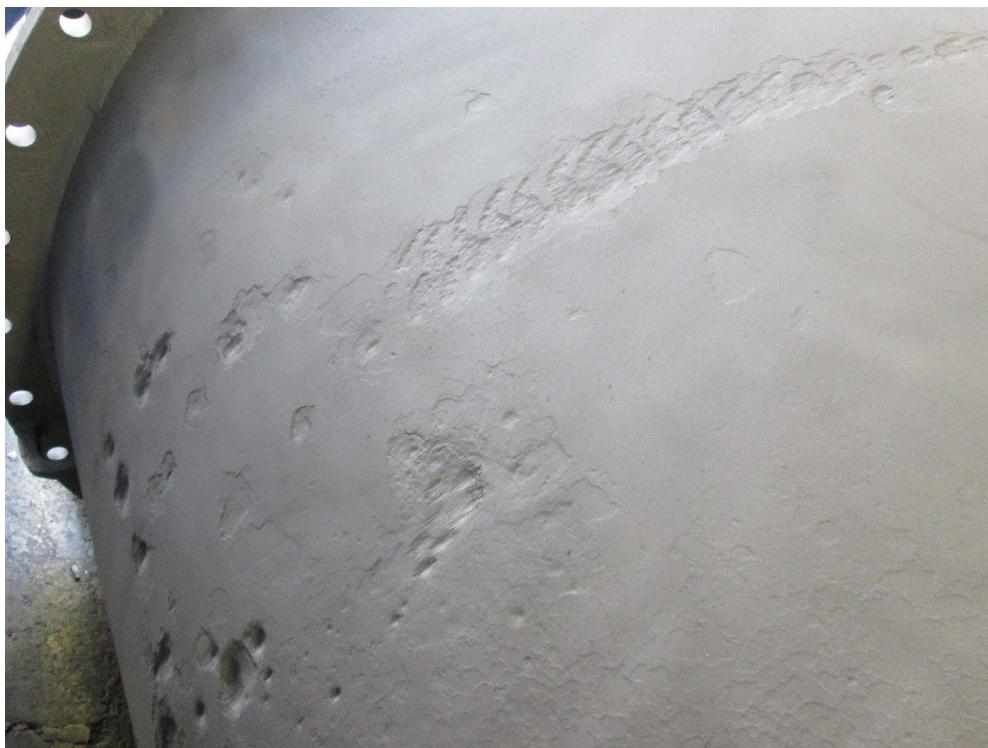
Pump column after media blasting w/ visible material loss

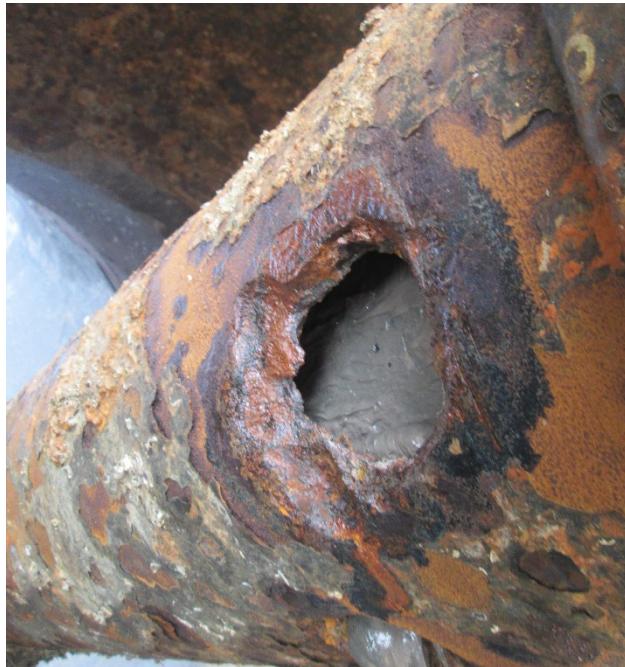
Pump shaft enclosure tube corroded with holes present (allowing water to enter bearings).

Pump shaft enclosure tube corrosion (full penetration)

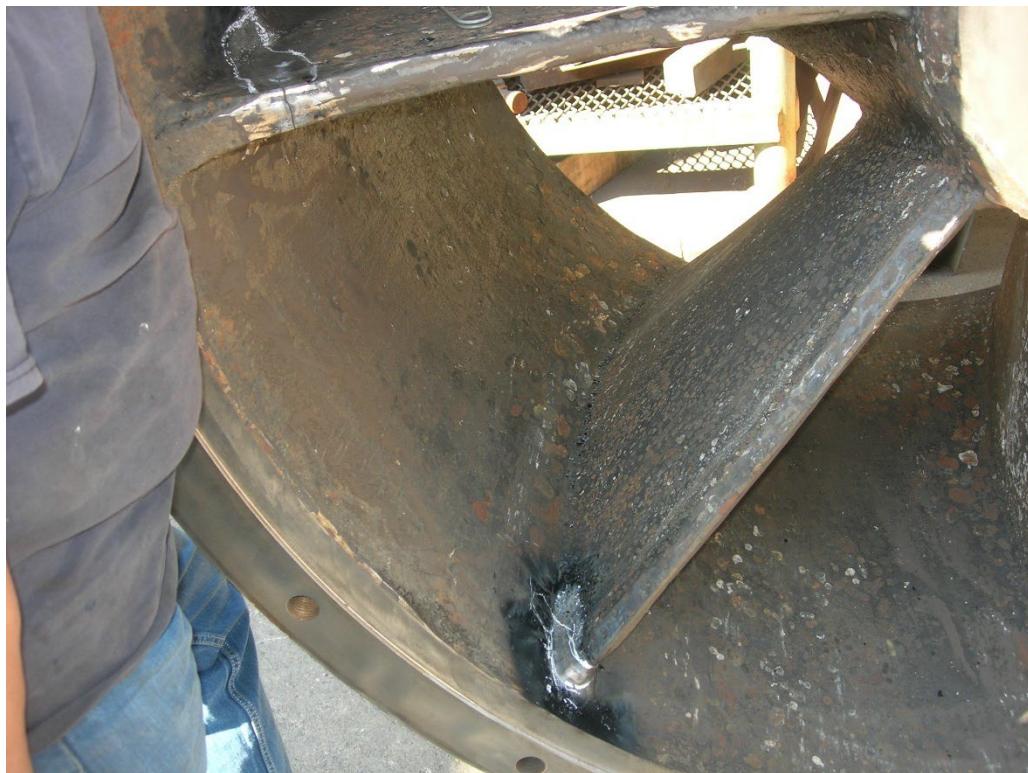
Diffuser legs cracked (pump section above propeller).

Pump diffuser section vane cracks (preparation for welding)

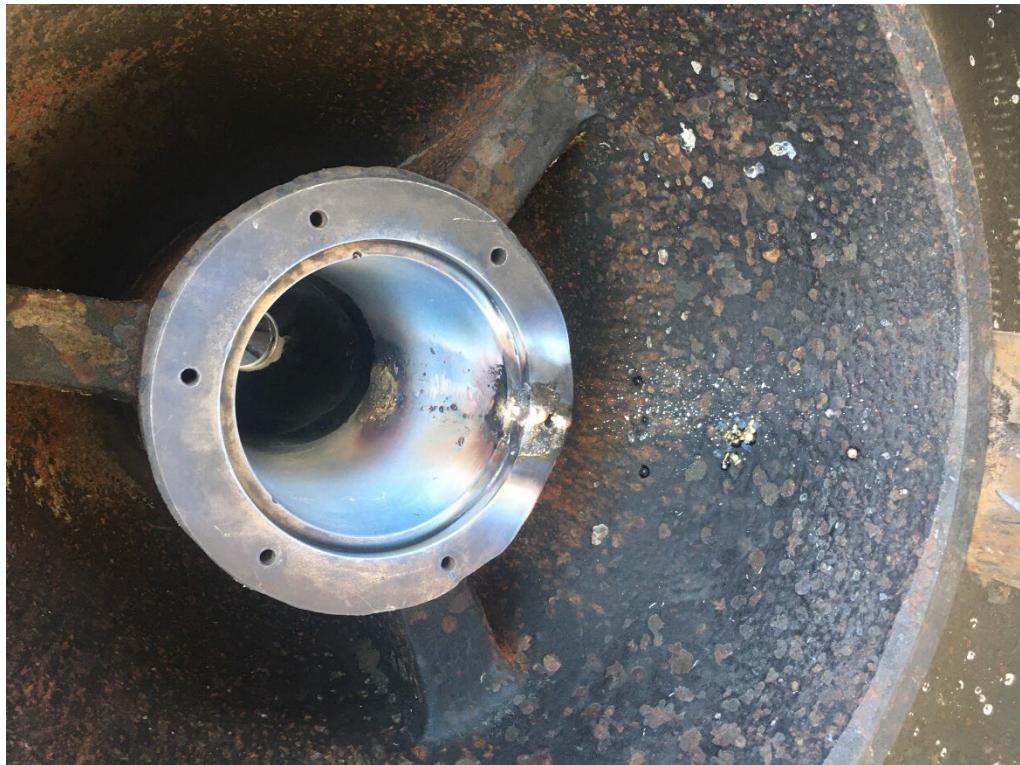
Suction bell bearing housing cracked longitudinally.

Pump suction bell bearing housing crack repair

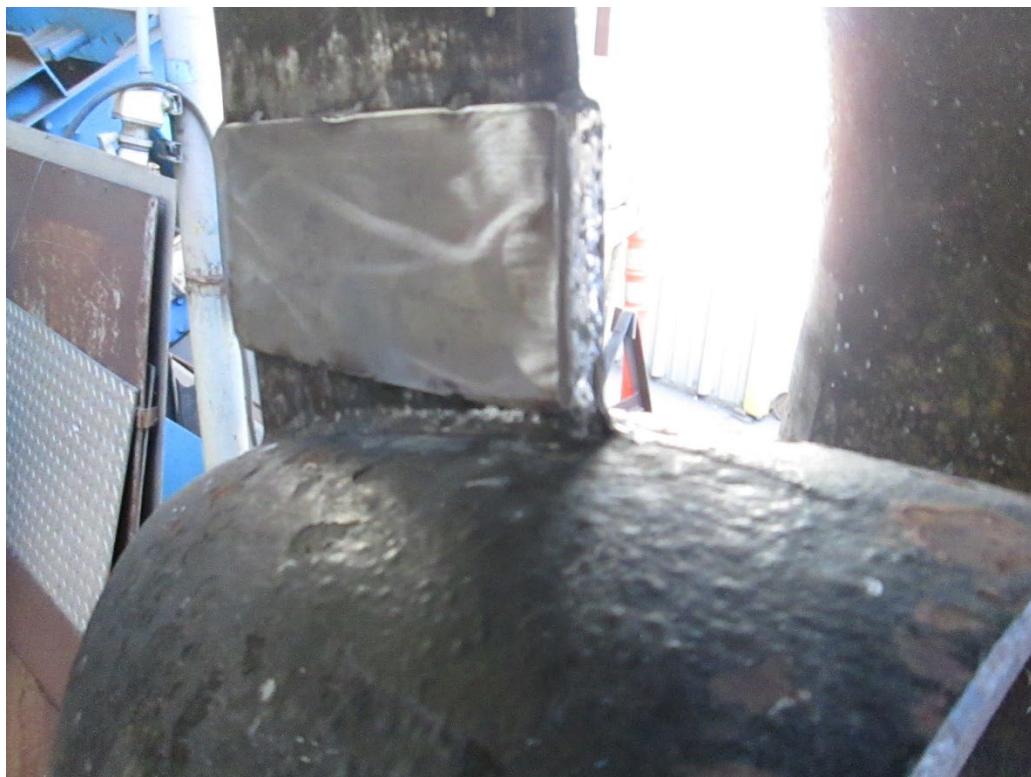
Suction bell shaft propeller stabilizer housing (nose cone) cracked, stabilizer legs cracked.

Pump suction bell stabilizer crack repair

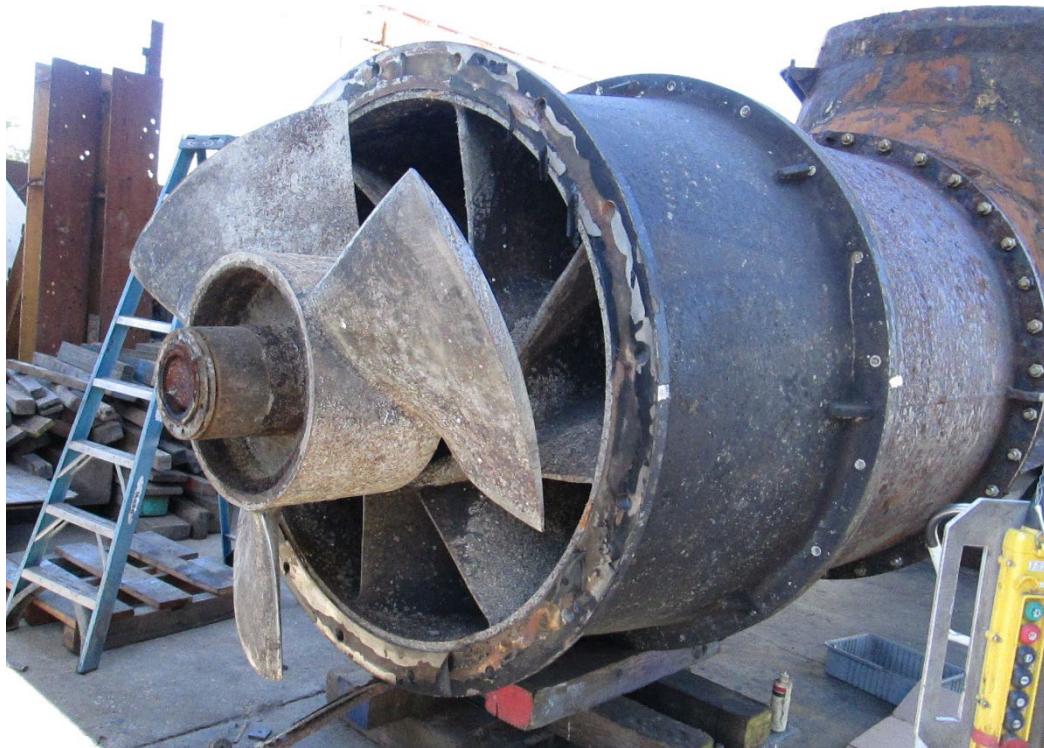
Appears lower pump shaft sheared at top of suction bell. Severe corrosion present.

Pump propeller w/ broken pump shaft visible

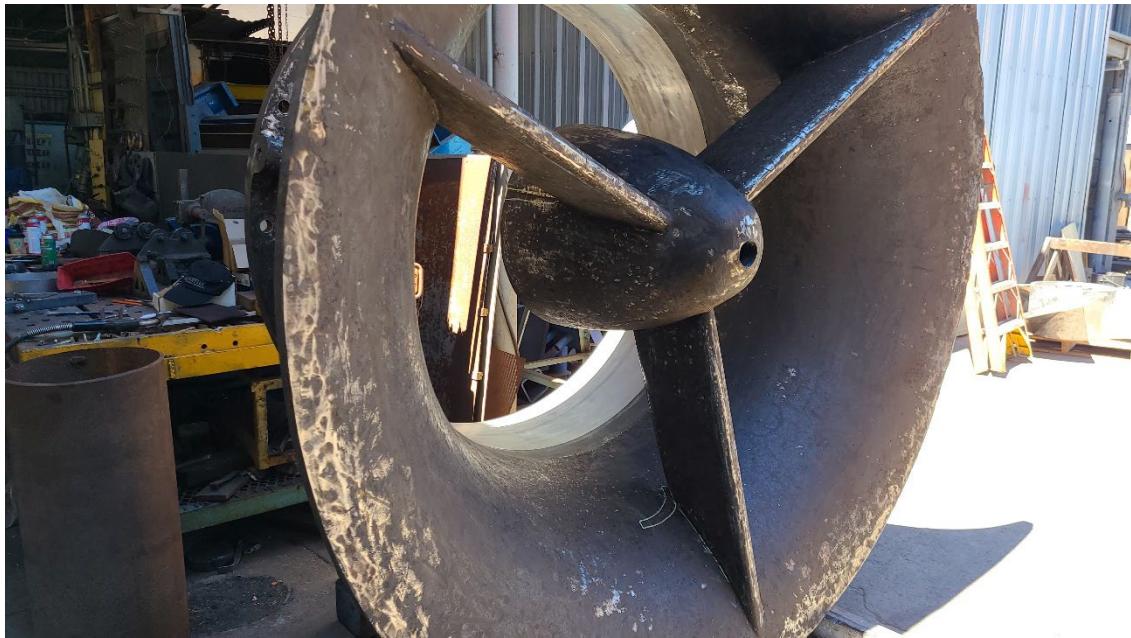
Suction bell shaft propeller stabilizer housing (nose cone) cracked, stabilizer legs cracked.

Several locations of suction bell outer housing cracks.

Pump suction bell and bearing housing w/ cracks highlighted for repair

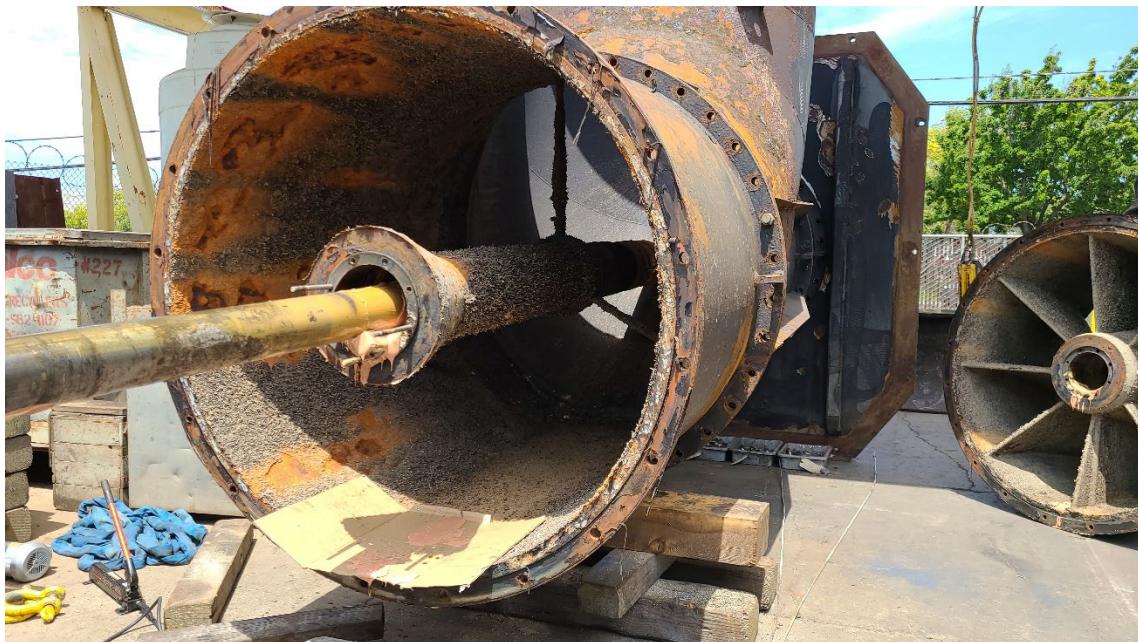
Upper portion of pump shaft enclosure tube severe corrosion.

Pump column and shaft enclosure tube w/ visible corrosion
