November 18, 2021  
Revised February 14, 2023  
Revised June 16, 2023

Harvest Properties  
C/O Claire Wang  
180 Grand Avenue, Suite 1400  
Oakland, CA 94612

## Monarch Consulting Arborists

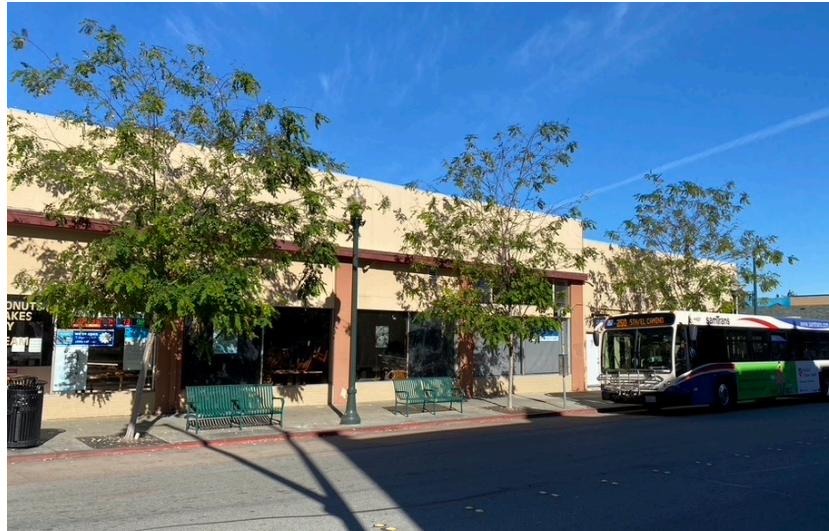
There are no “Heritage Trees” as defined by the ordinance and all three trees are “Street Trees”. The three trees are all black locust (*Robinia pseudoacacia*) with 5 inch trunk diameters and approximately 25 feet tall with crown diameters of about 15-20 feet.

**IMAGE 1: BLACK LOCUST STREET TREES ALONG FIRST STREET**

All three trees are young and in good condition.

1. Protect the trunks of the trees from mechanical damage by wrapping with wattle or bracing with timbers.
2. All tree maintenance, care, and removals shall be performed by a qualified arborist with a C-61/D-49 California Contractors License. Tree maintenance and care shall be specified in writing according to American National Standard for Tree Care Operations: *Tree, Shrub and Other Woody Plant Management: Standard Practices* parts 1 through 10 and adhere to ANSI Z133.1 safety standards and local regulations. All maintenance is to be performed according to ISA Best Management Practices.

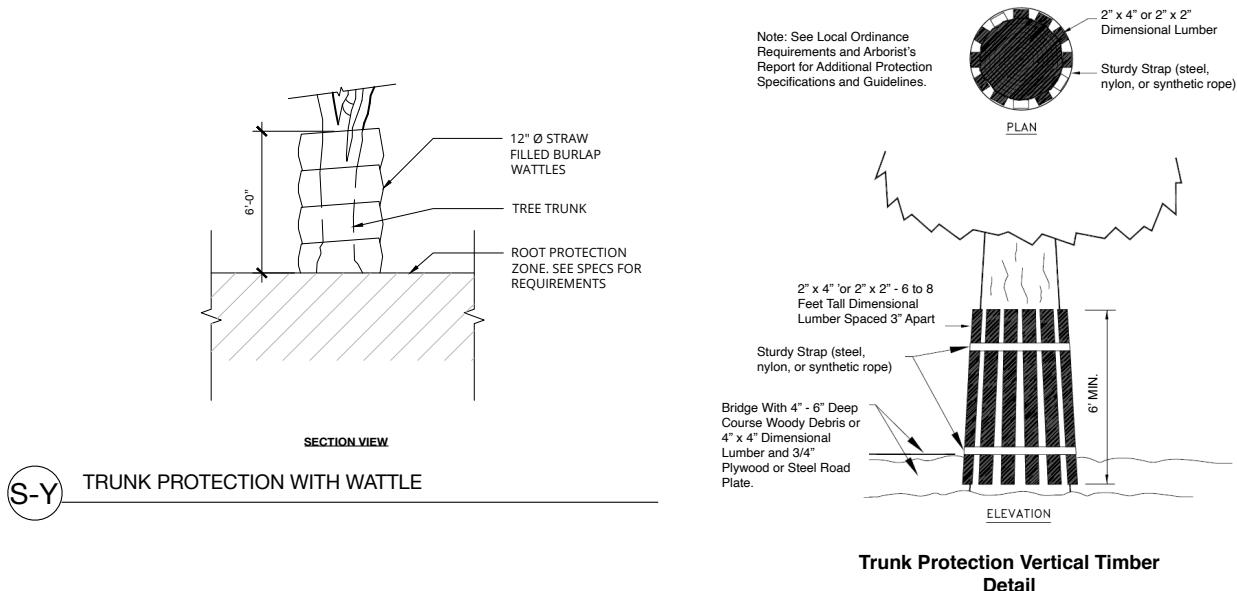
Tree protection focuses on avoiding damage to the roots, trunk, or scaffold branches from heavy equipment. Either method indicated below will accomplish the required protection by bracing with vertical timbers or wrapping with wattle.
