Visual Hazardous Building Materials Survey

401–445 South B Street, San Mateo, California 94401

January 20, 2023

Project Number 0397.003.001

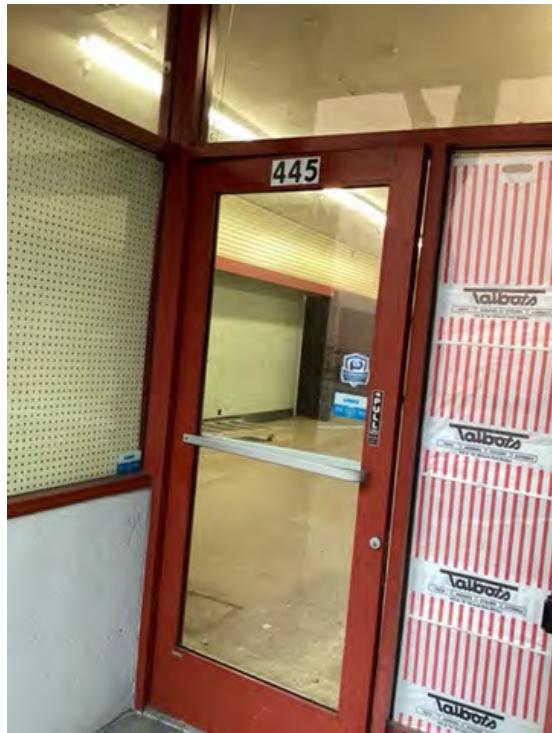
Photograph 1:

View depicting the main entrance to 445 South B Street.

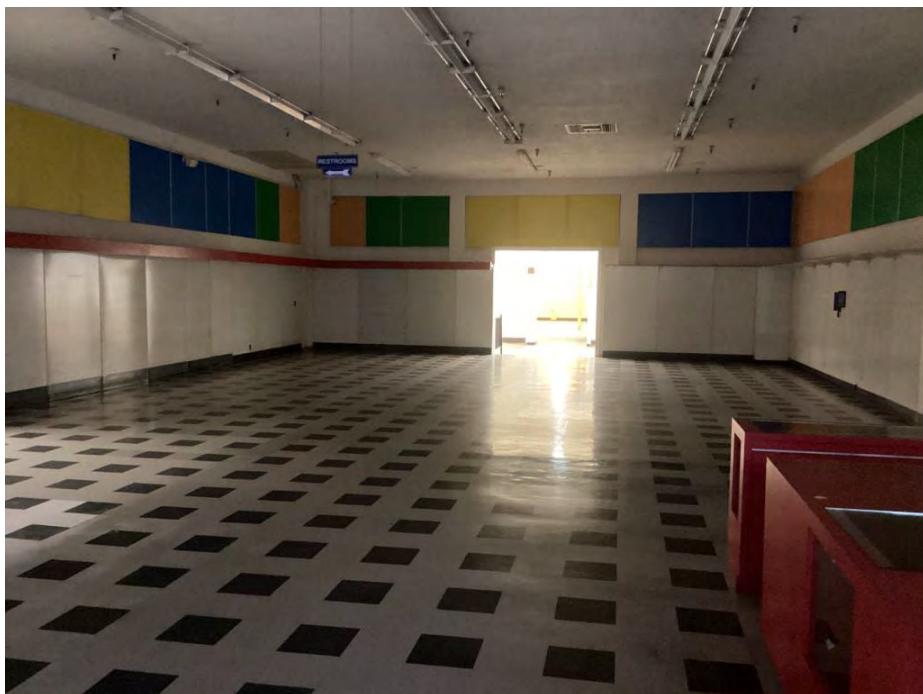
Photograph 2:

View depicting the interior of 445 South B Street.

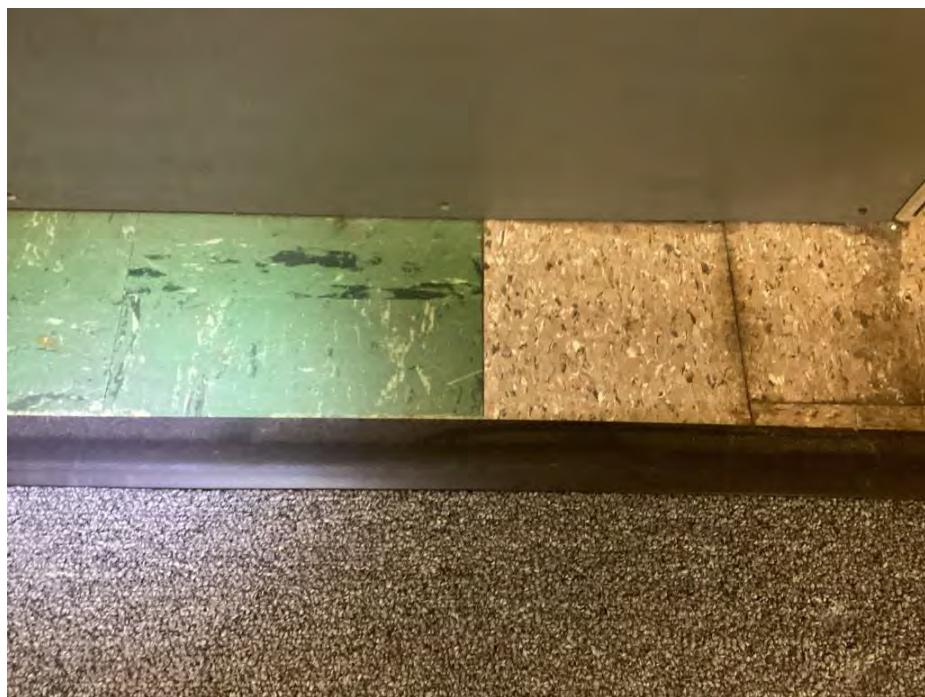
Photograph 3:

View depicting green 9-inch vinyl tiles located in 445 South B Street.

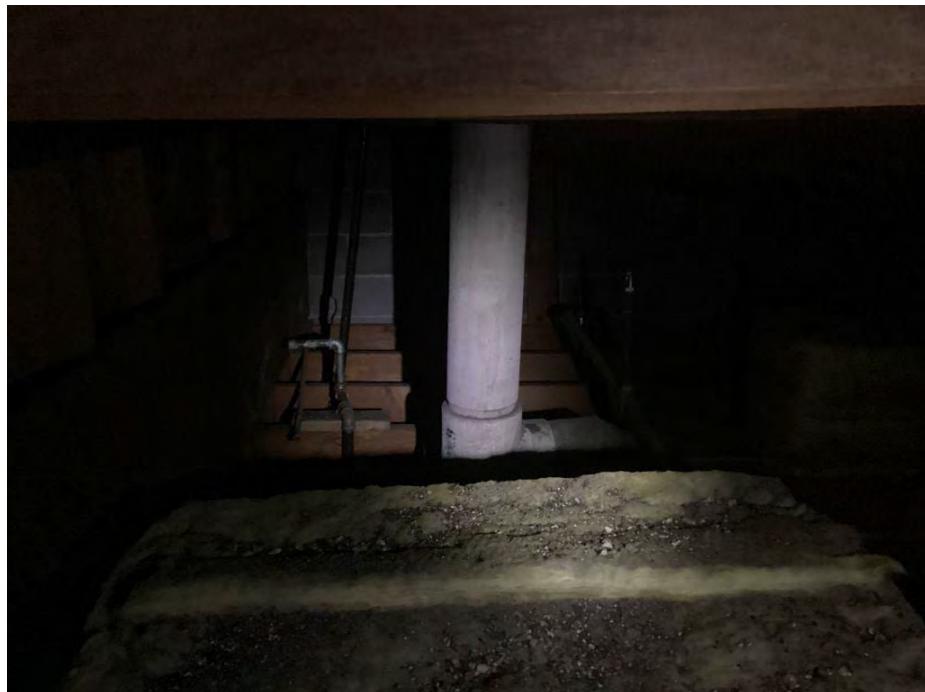
Photograph 4:

The potential exists for underground utilities constructed with asbestos cement (e.g., Transite™ water pipelines) and/or naturally occurring regulated material to be present beneath the Site. A photographic log is included in Appendix B and copies of inspector certifications are included in Appendix C.

View depicting the gray cementitious pipe (resembling Transite™) in the plenum space of 445 South B Street.

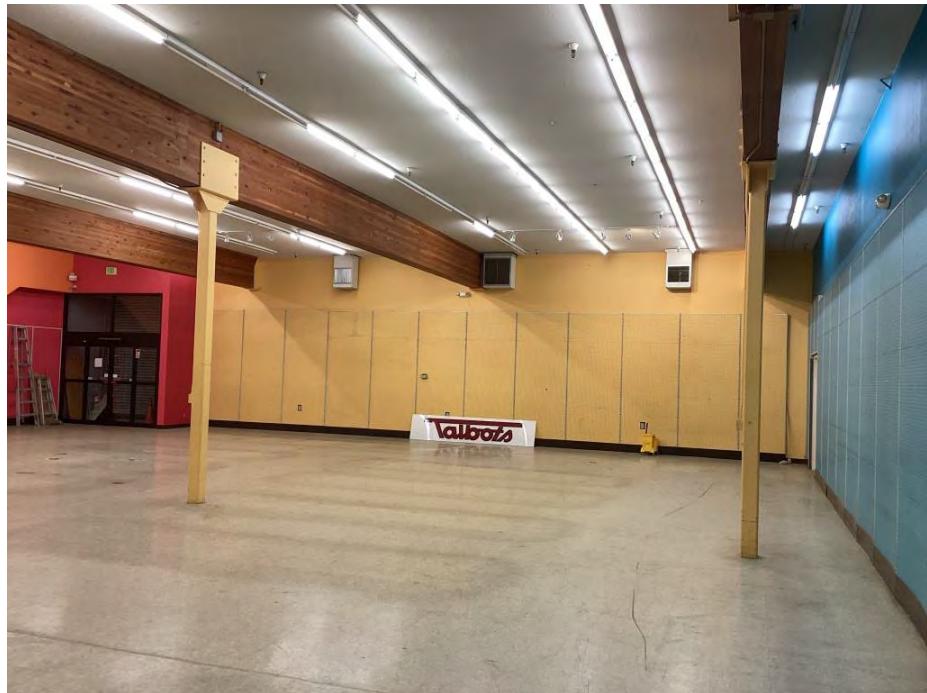
Photograph 5:

View depicting the addition to 445 South B Street.

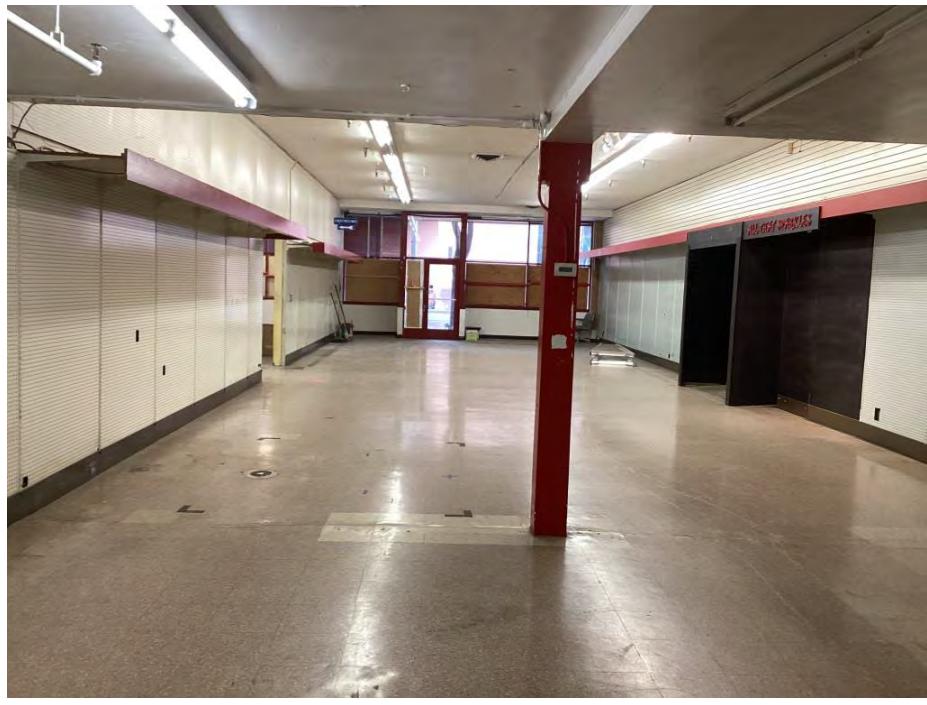
Photograph 6:

View depicting the Hobby area associated with 445 South B Street.

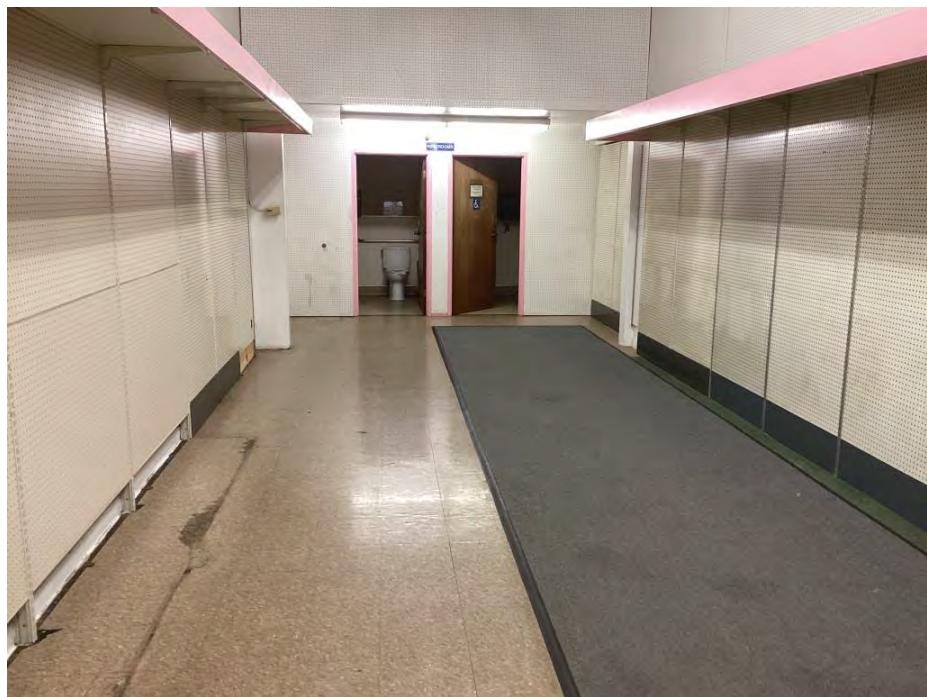
Photograph 7:

View depicting the Dolls area associated with 445 South B Street.

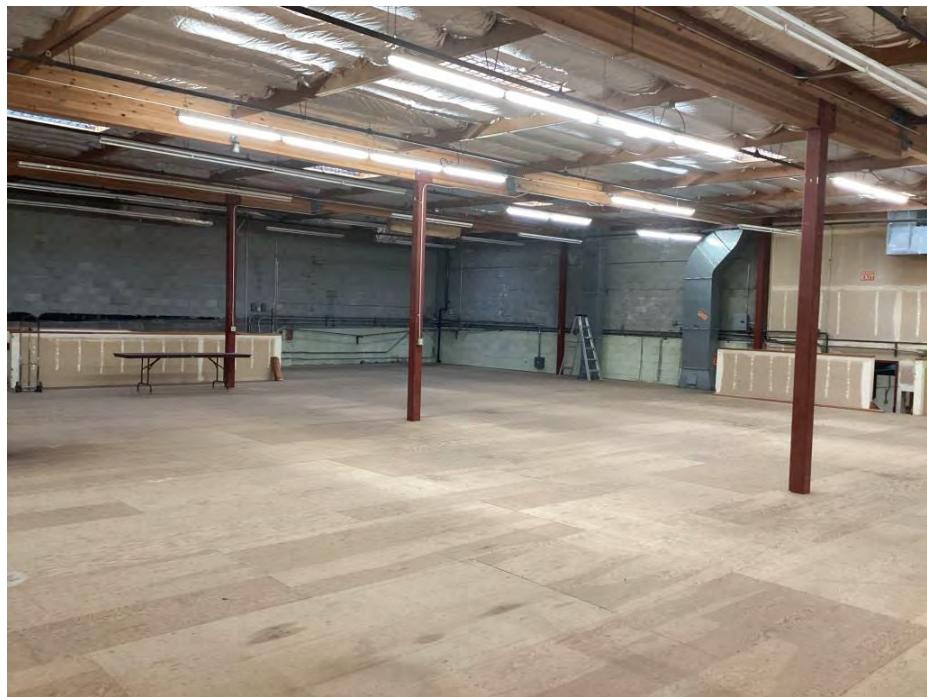
Photograph 8:

View depicting the second-floor storage associated with 445 South B Street.

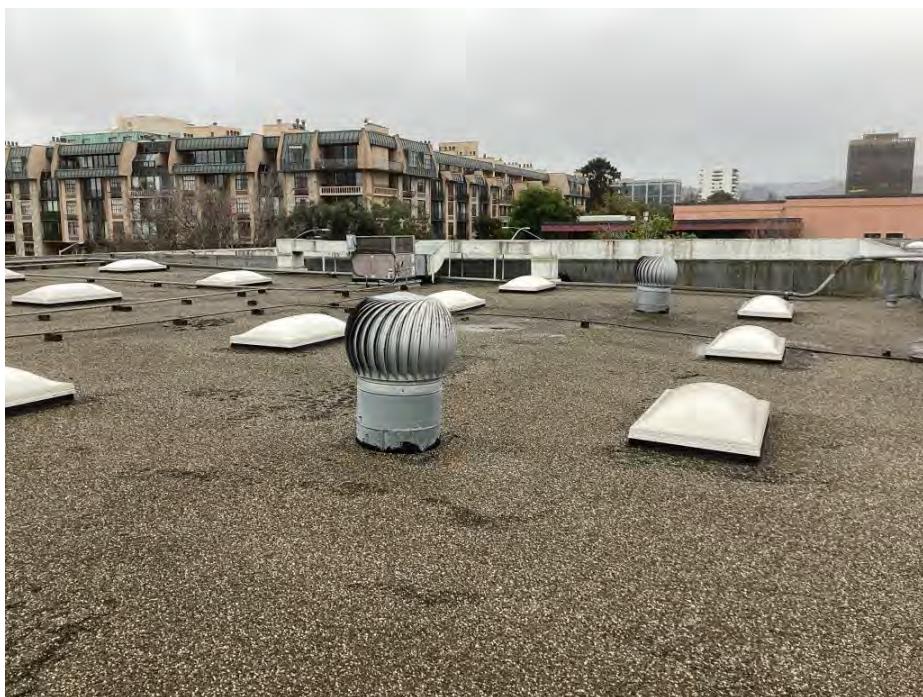
Photograph 9:

View depicting the roof of 445 South B Street (south half).

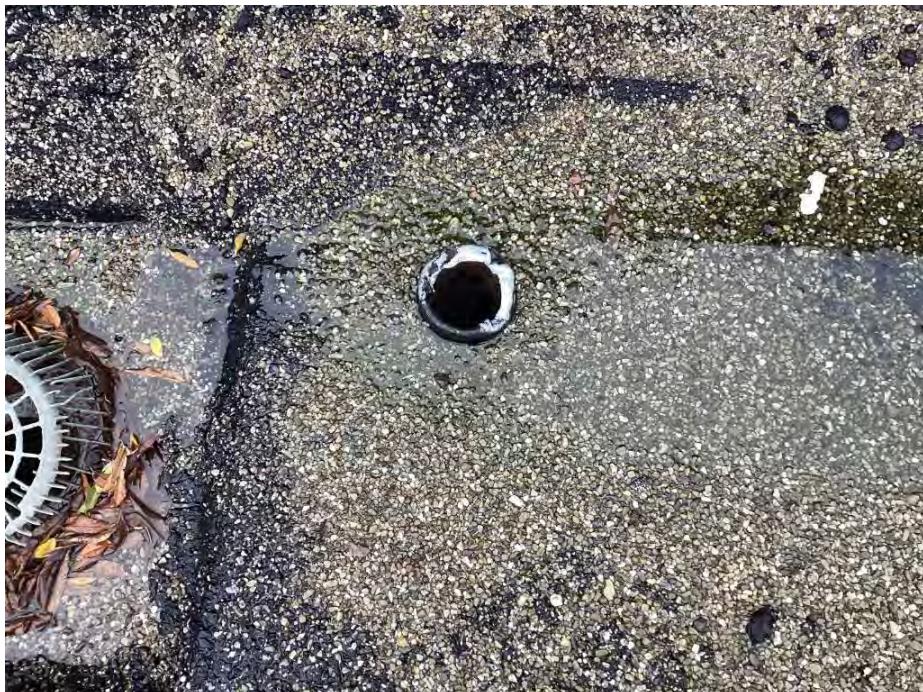
Photograph 10:

View depicting the lead wrapped pipe on the roof of 445 South B Street (south half).

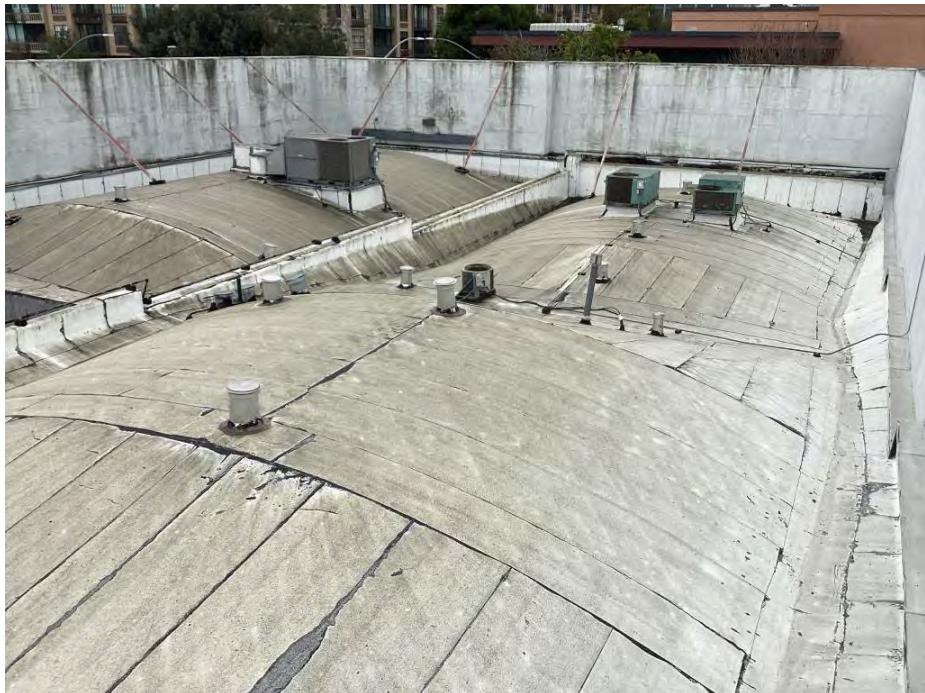
Photograph 11:

View depicting the roof of 445 South B Street (north half).

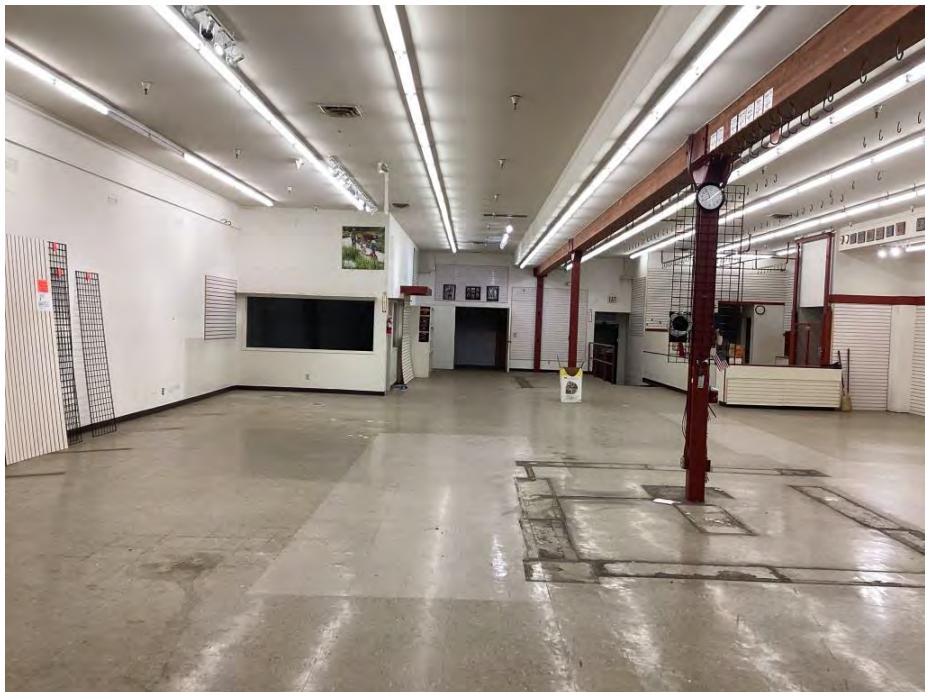
Photograph 12:

View depicting the interior of 415 South B Street.

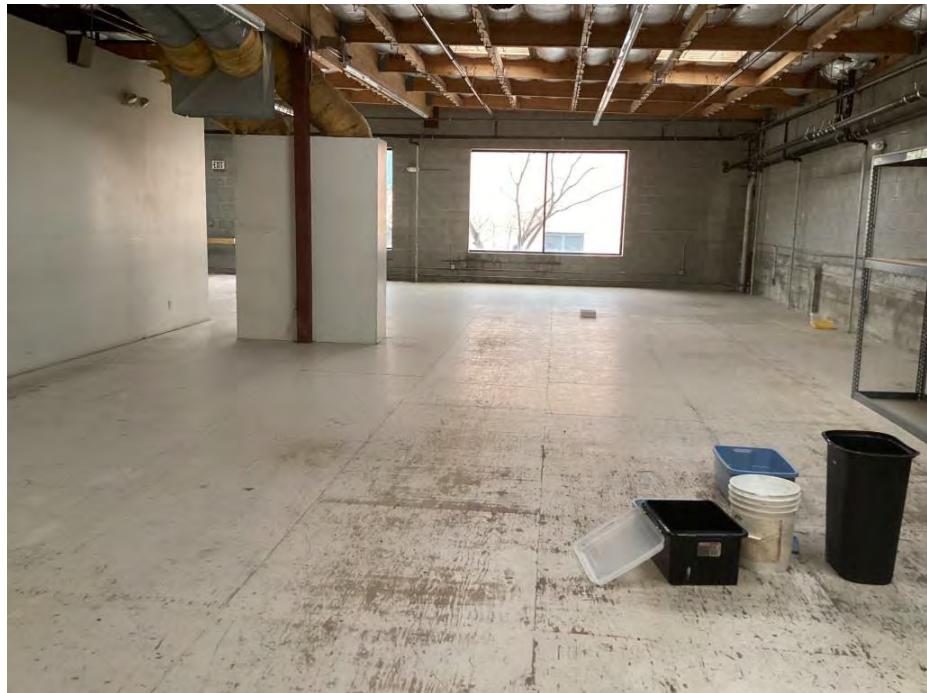
Photograph 13:

View depicting the warehouse area associated with 415 South B Street.

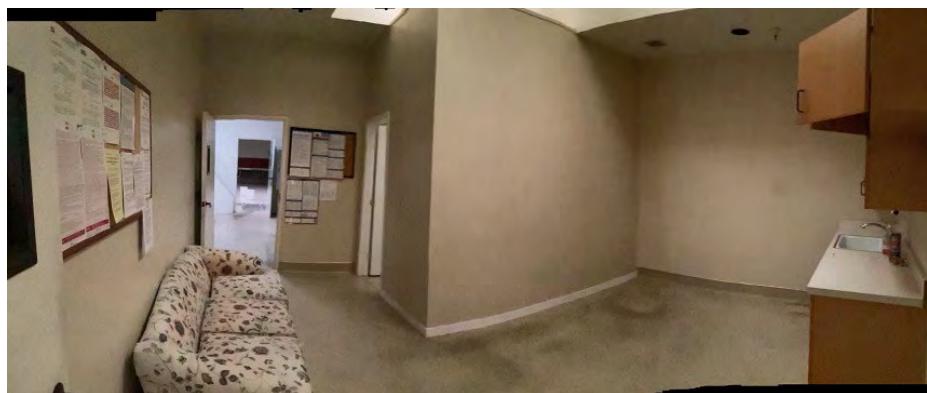
Photograph 14:

View depicting the break room associated with 415 South B Street.

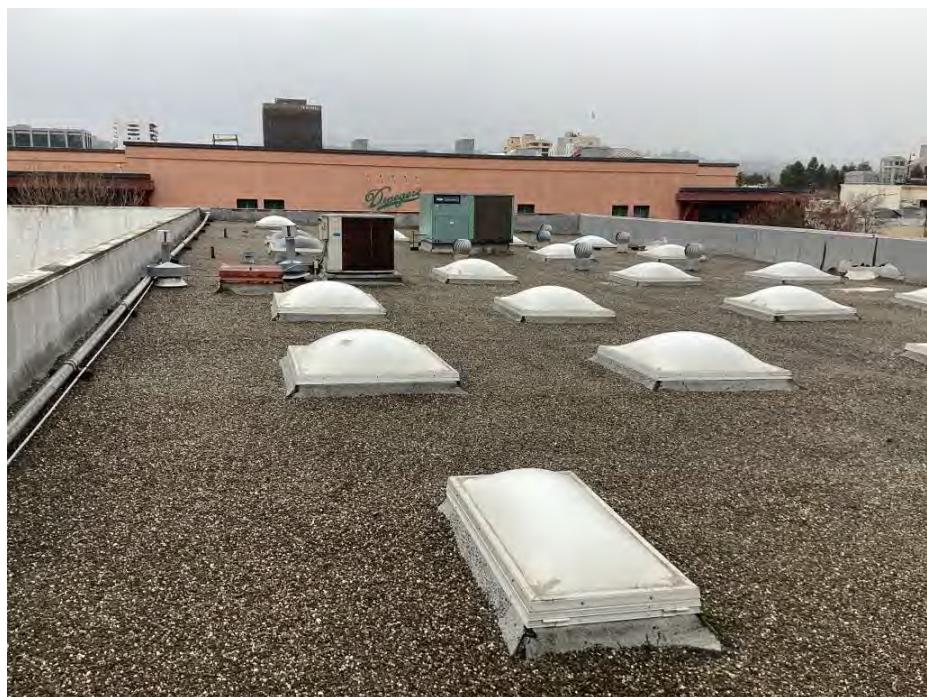
Photograph 15:

View depicting the roof of 415 South B Street (north half).

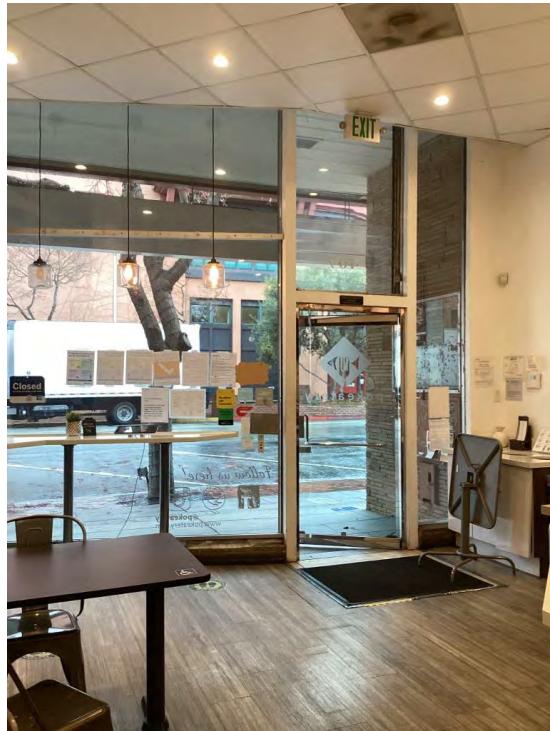
Photograph 16:

View depicting the interior of 407 South B Street.

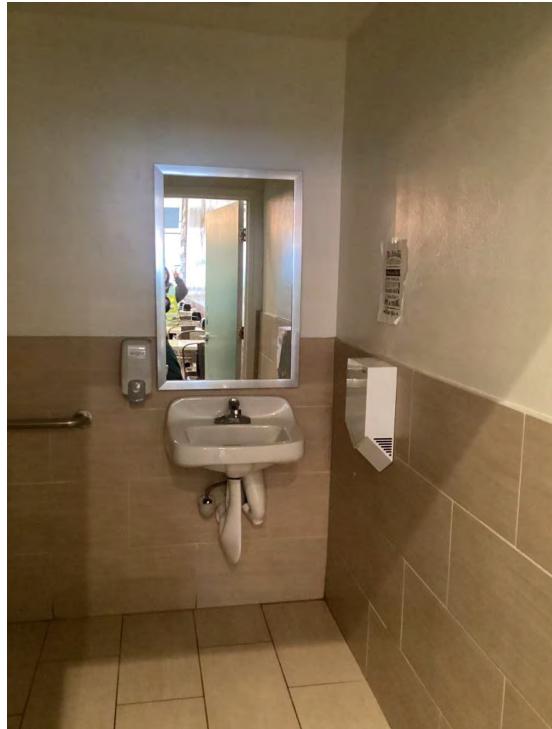
Photograph 17:

View depicting the restroom of 407 South B Street.

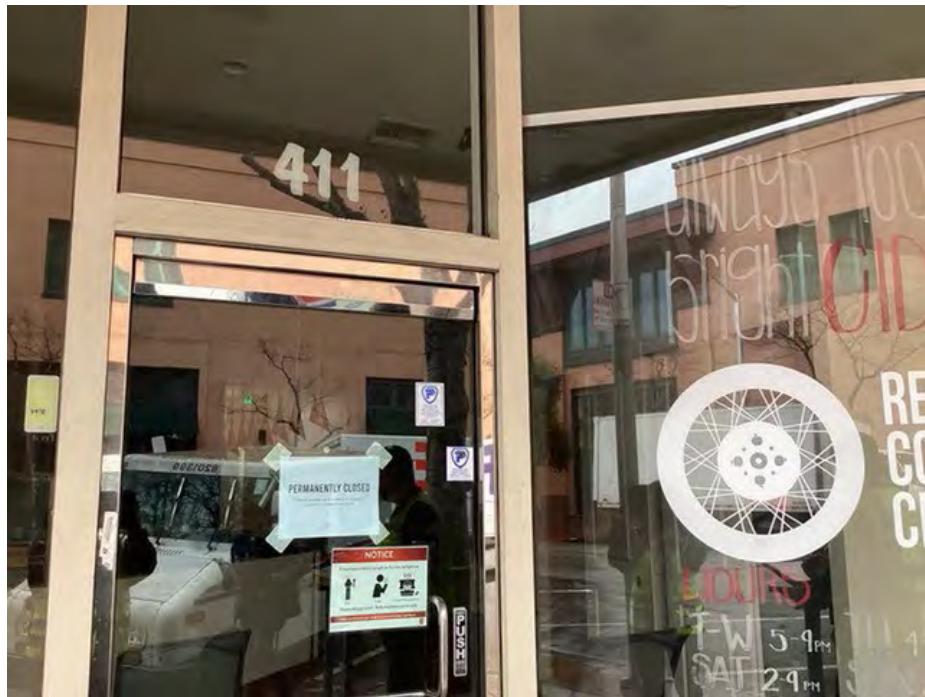
Photograph 18:

View detecting the entrance to 411 South B Street).

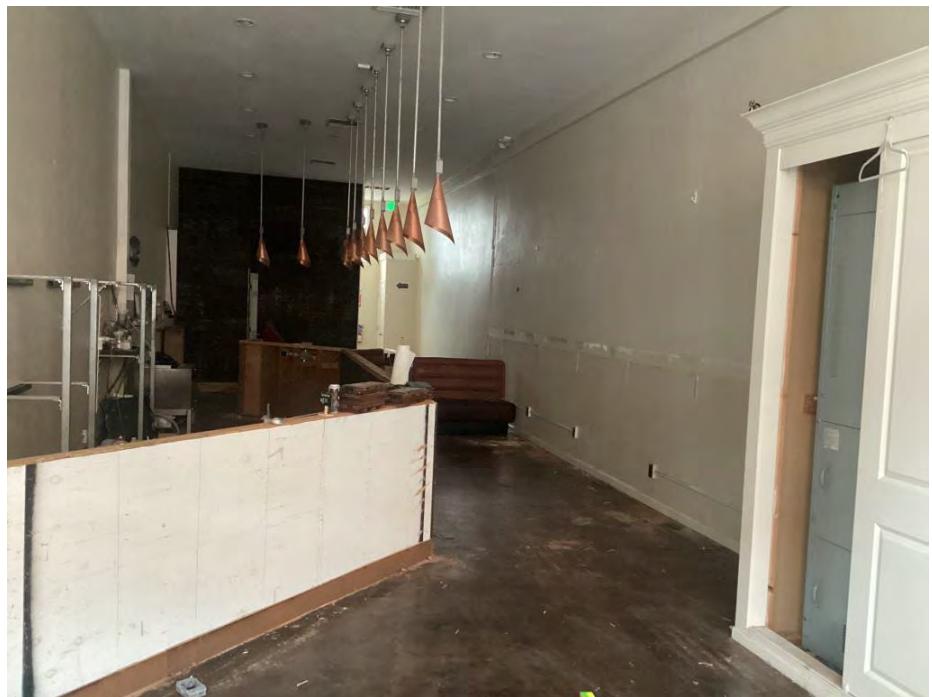
Photograph 19:

View depicting the interior of 411 South B Street.

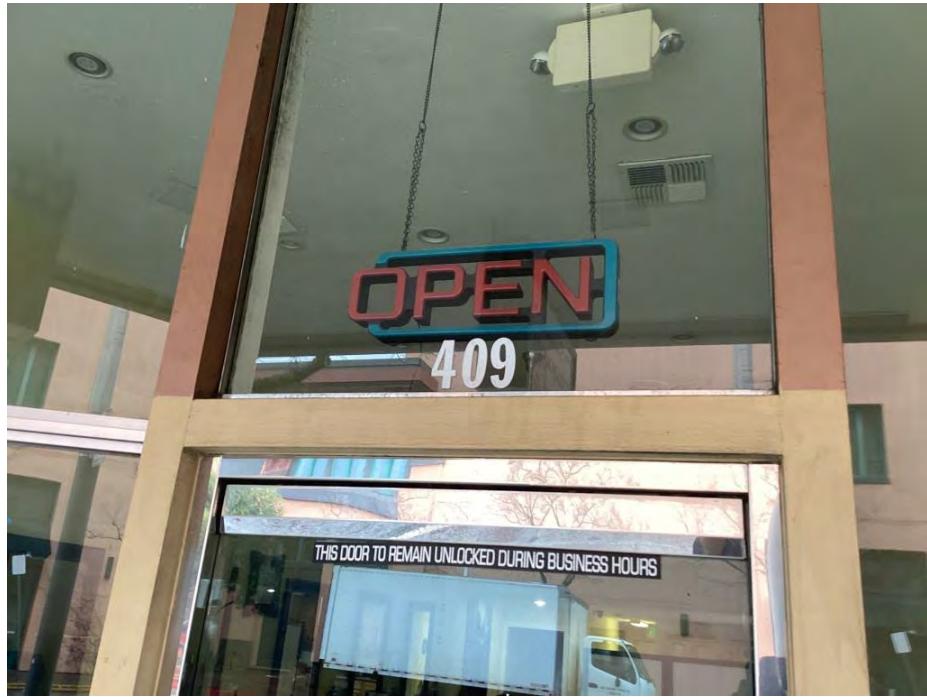
Photograph 20:

View depicting the entrance to 409 South B Street.

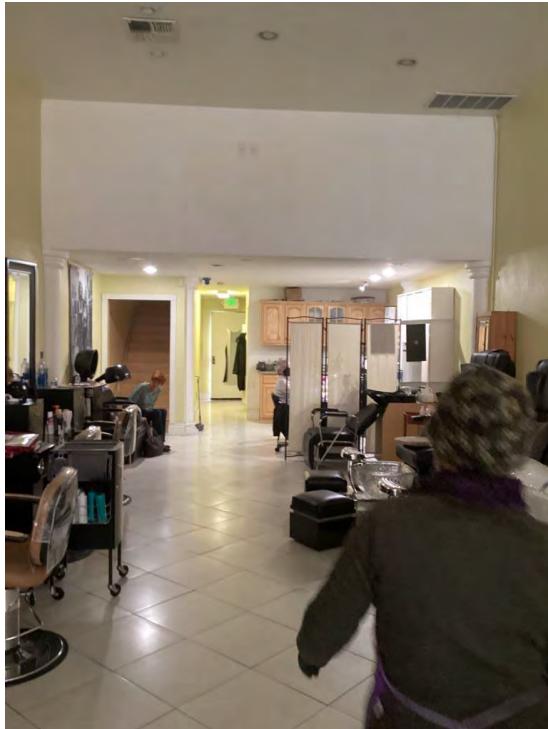
Photograph 21:

View depicting the interior 409 South B Street.

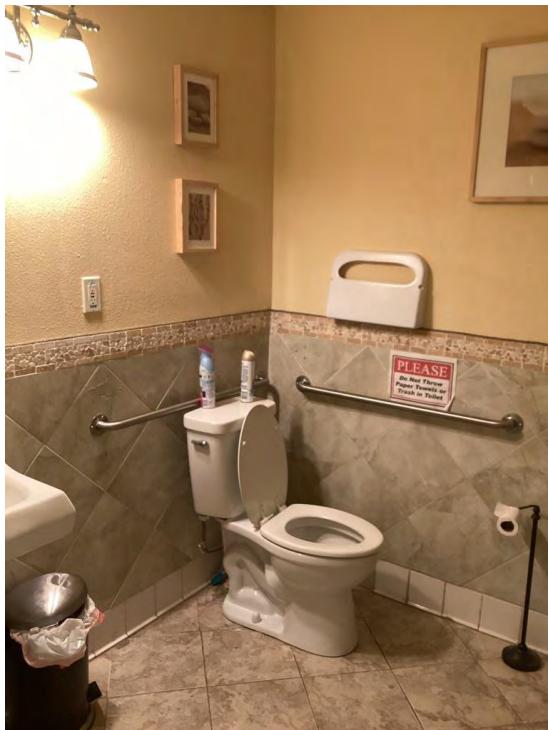
Photograph 22:

View depicting the restroom of 409 South B Street.

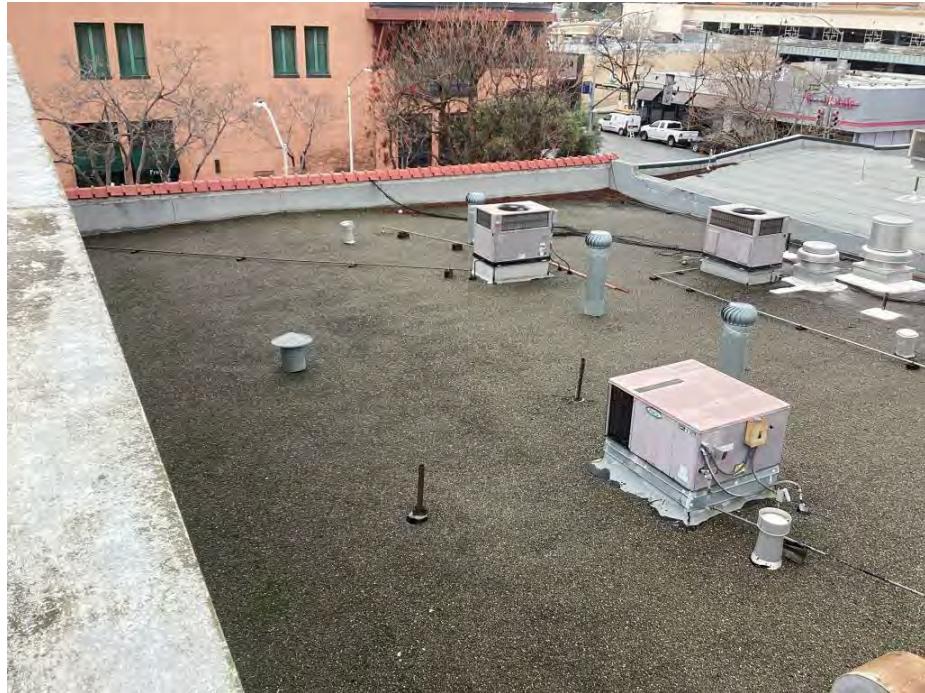
Photograph 23:

View depicting the roof of 407, 409, and 411 South B Street.

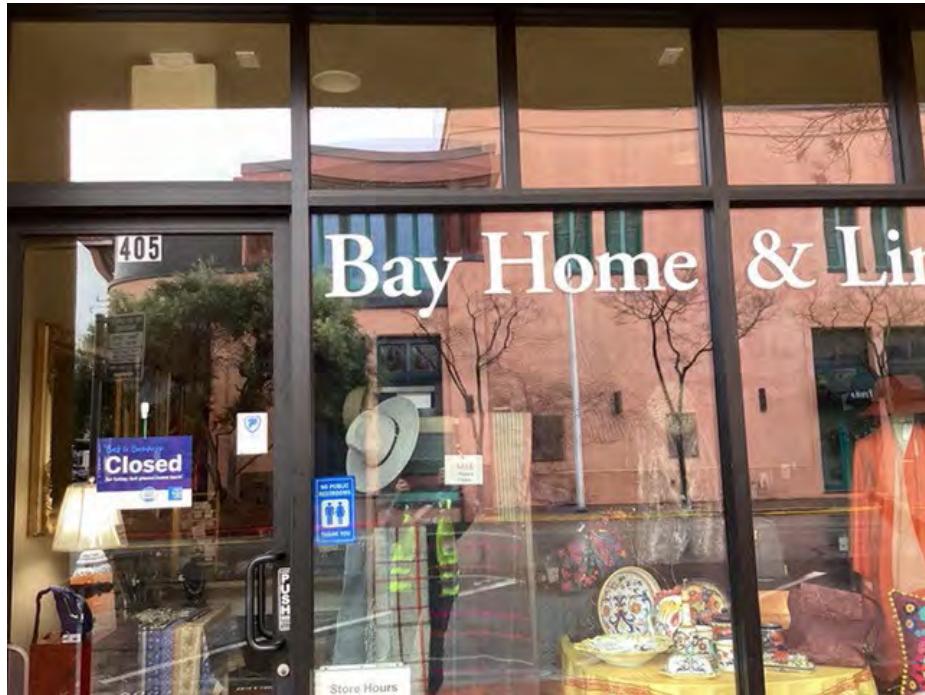
Photograph 24:

View depicting the entrance to 405 South B Street.

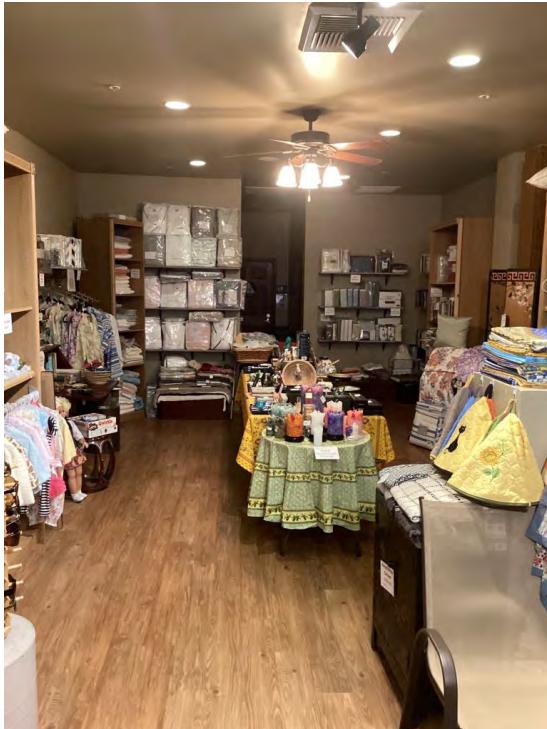
Photograph 25:

View depicting the interior of 405 South B Street.

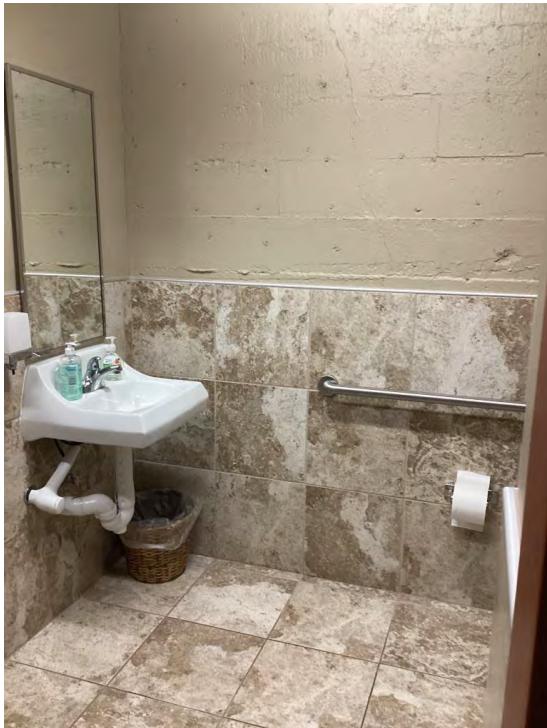
Photograph 26:

View depicting typical restroom of 405 South B Street.

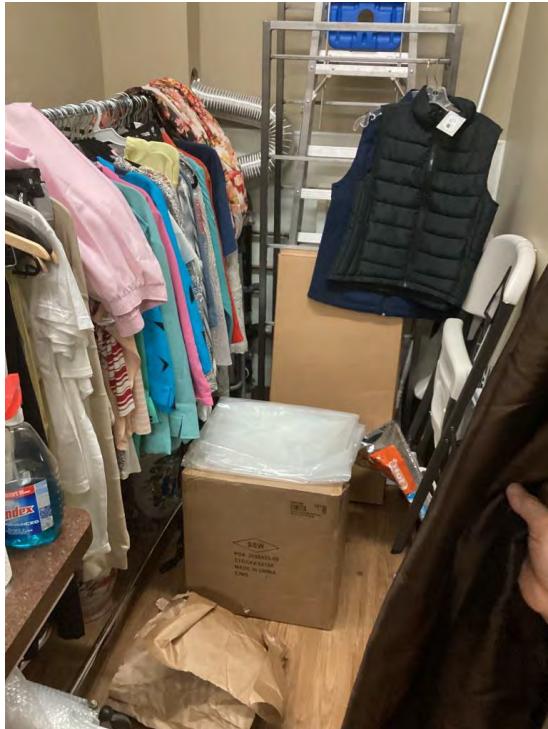
Photograph 27:

View depicting the storage closet of 405 South B Street.

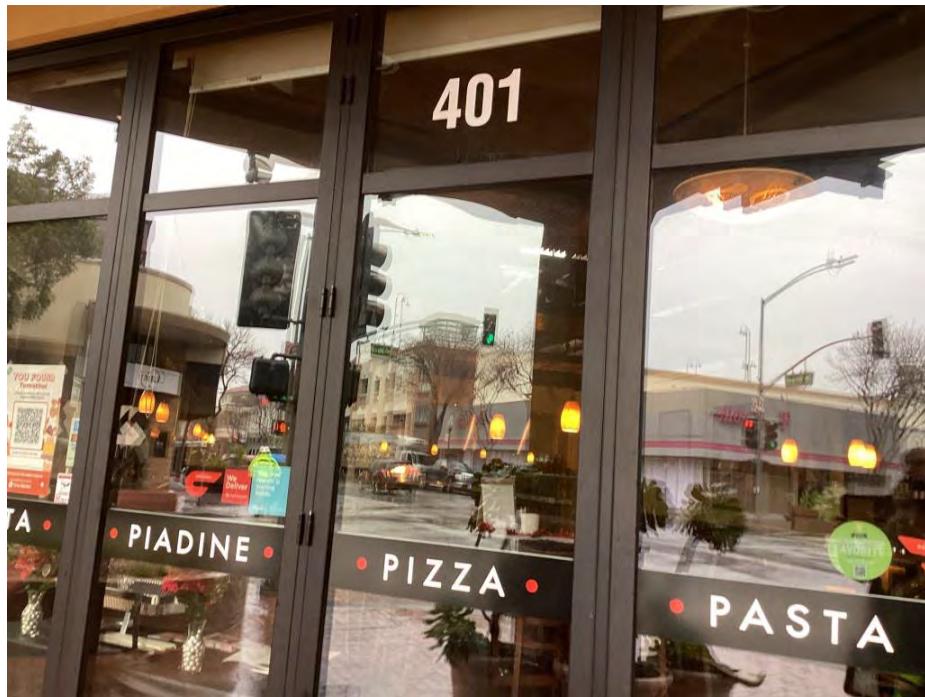
Photograph 28:

View depicting the entrance of 401 South B Street.

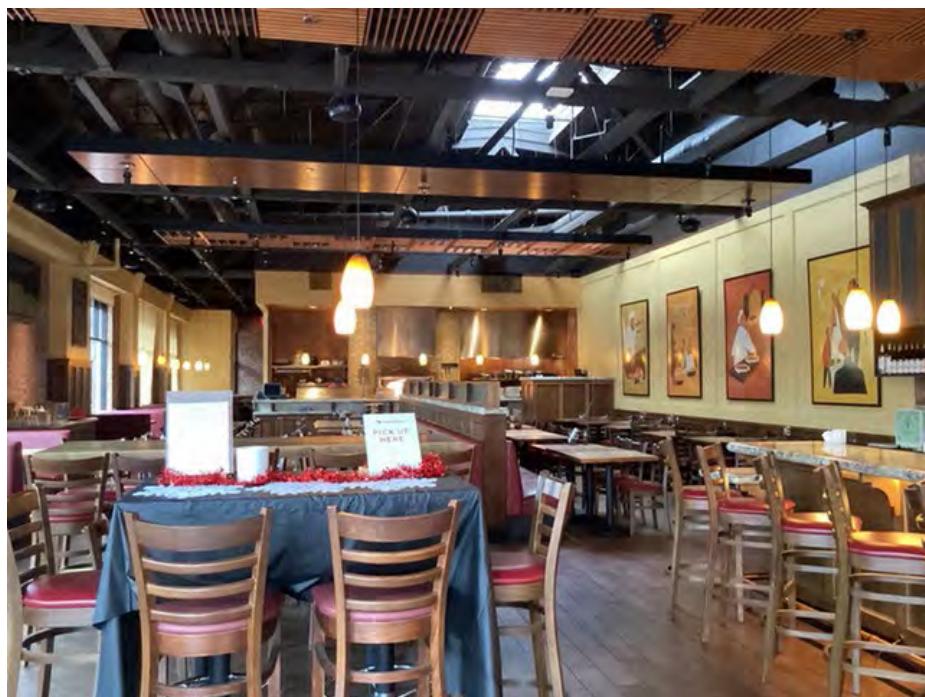
Photograph 29:

View depicting the interior of 401 South B Street.

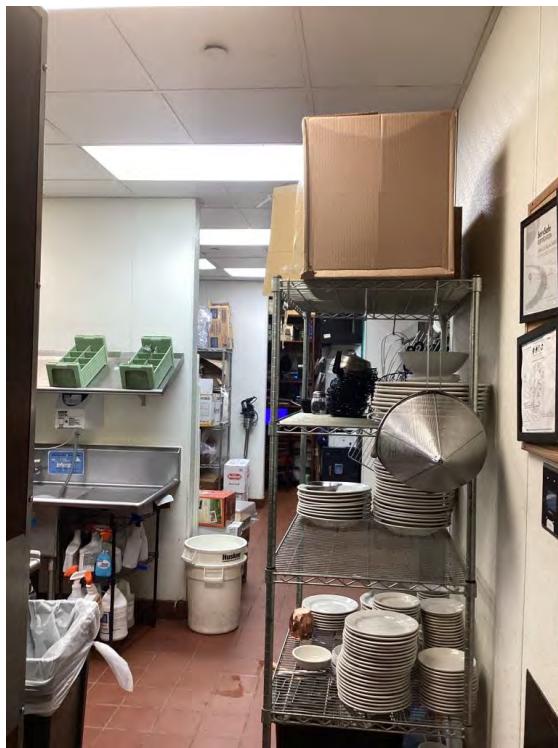
Photograph 30:

View depicting the kitchen of 401 South B Street.

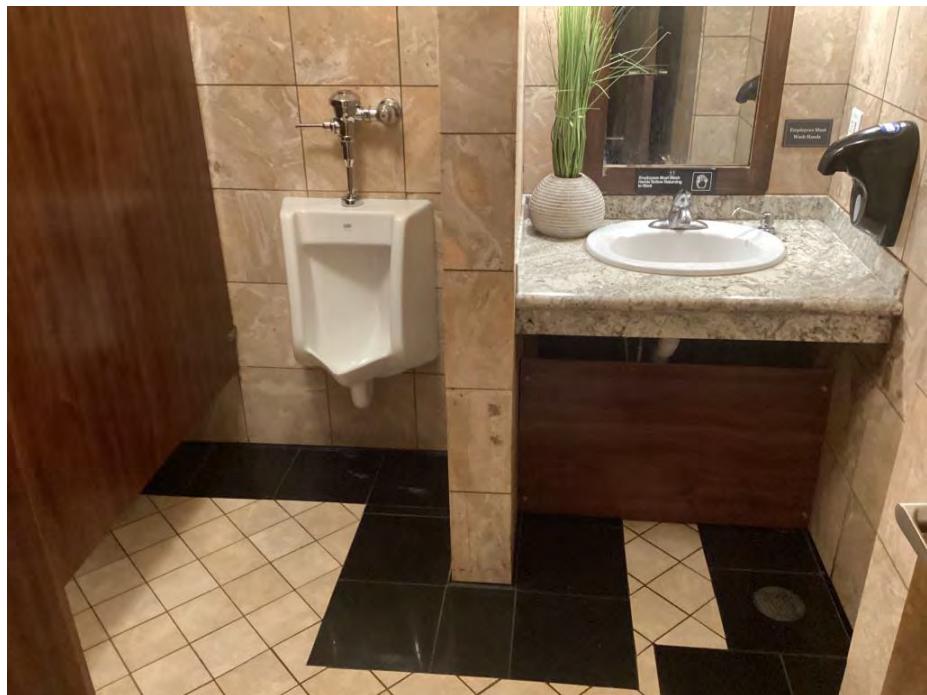
Photograph 31:

View depicting the typical restroom of 401 South B Street.

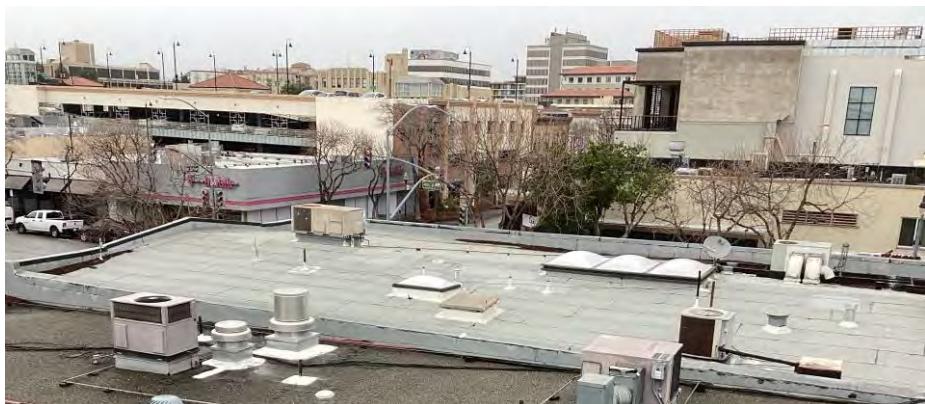
Photograph 32:

View depicting the roof (center, light gray) of 401 and 405 South B Street.
