Tree Preservation Report

TREE PRESERVATION REPORT FOR PENINSULA HEIGHTS

2655, 2755, 2800 & 2988 Campus Drive, San Mateo

February 6, 2020 (Revised 5/21/20 per plan check comments & retaining wall changes)

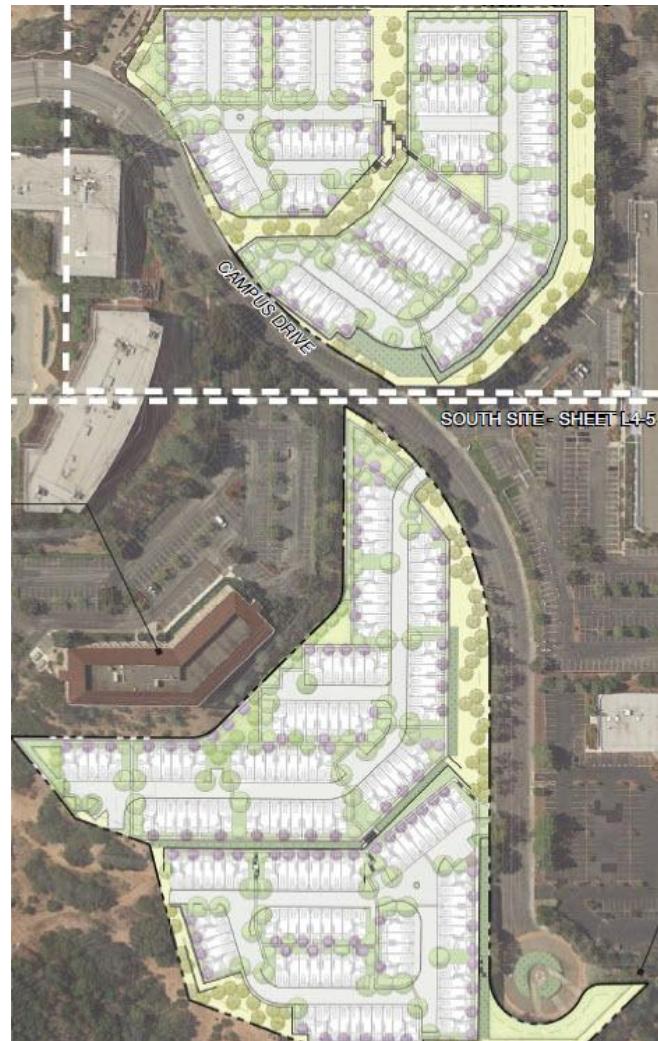
Figure 1. The 26-acre project area is divided into a north and south parcel, as shown in this capture from an early plan set (dated 5/8/19).
