GEOTECHNICAL INVESTIGATION
Proposed Commercial Development
2700 - 2790 South El Camino Real
San Mateo, California

Dated: September 12, 2013
Job 1130.14.00

RE: **GEOTECHNICAL INVESTIGATION**
Proposed Commercial Development
2700-2790 South El Camino Real
San Mateo, California

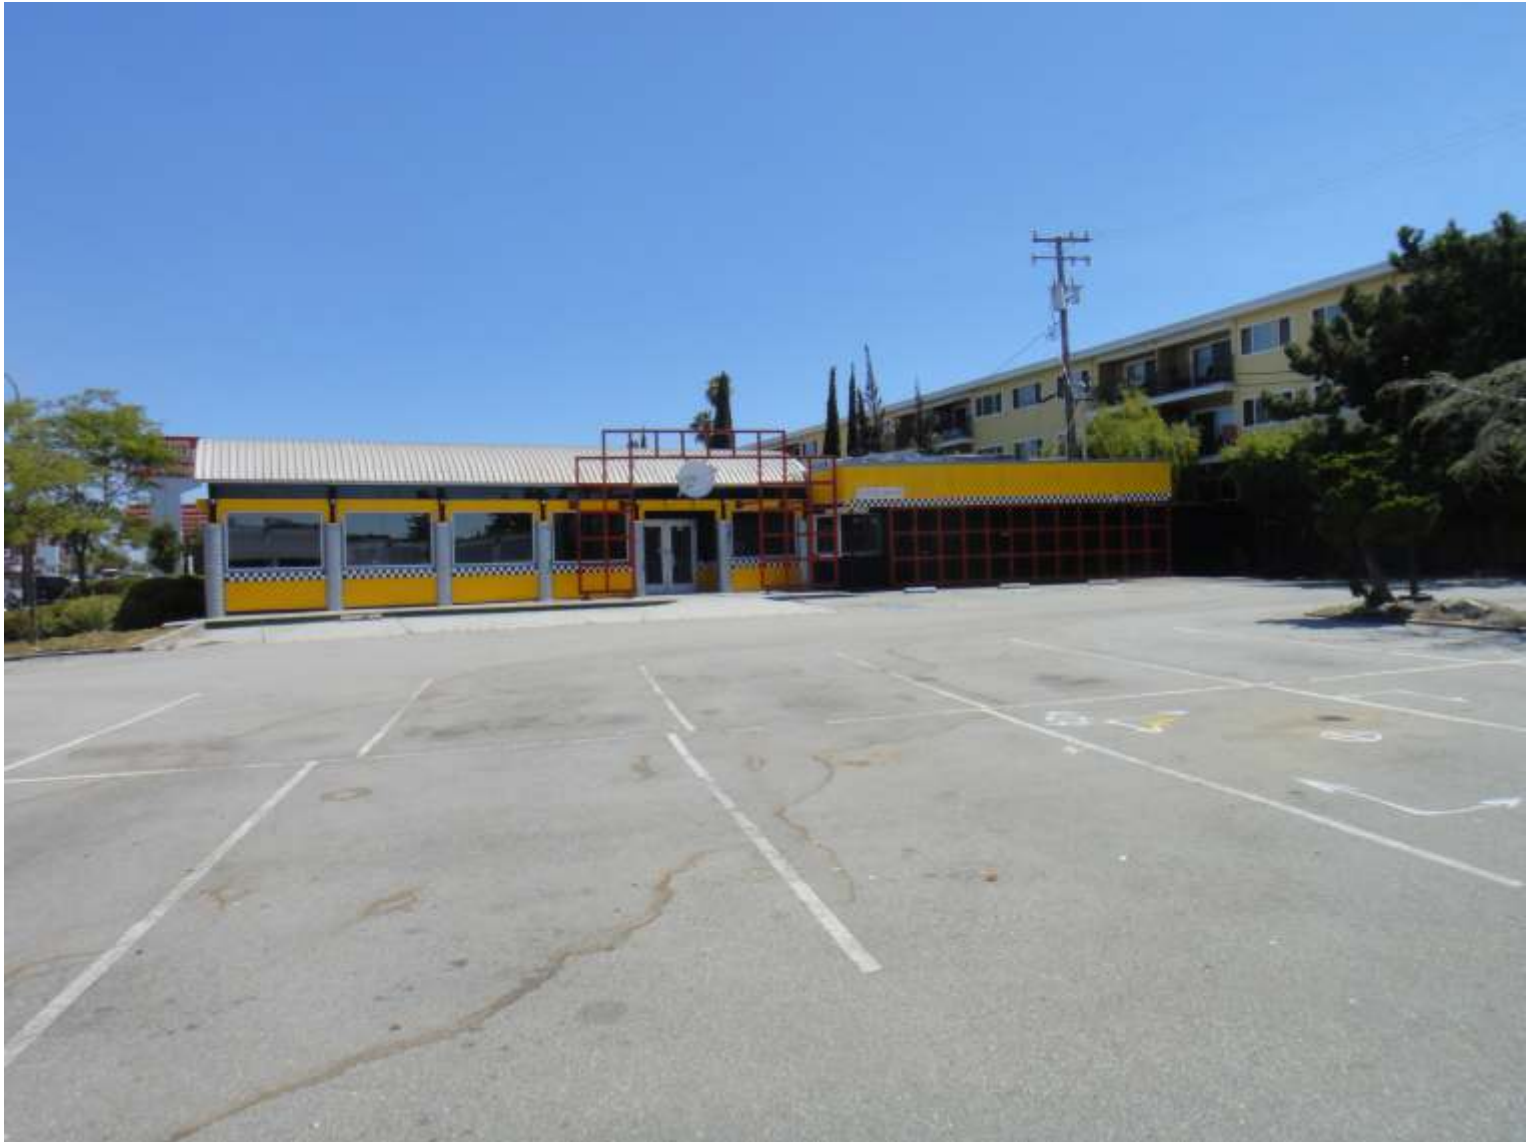
Photo 1 - Southerly view across 2700 parking lot toward existing building. Multi-residential building borders western side of property in upper right of view.

The northern two-thirds of the site are occupied by generally intact commercial developments including paved parking lots and commercial buildings, and isolated landscaping (Photos 1 and 2; Plate 2). The vacant lot (2790) was occupied by a service station. The rear of the site is bordered by a dense stand of mature trees, and there isolated landscaping elsewhere, with exposed soil and sparse weed distribution on the vacant parcel.

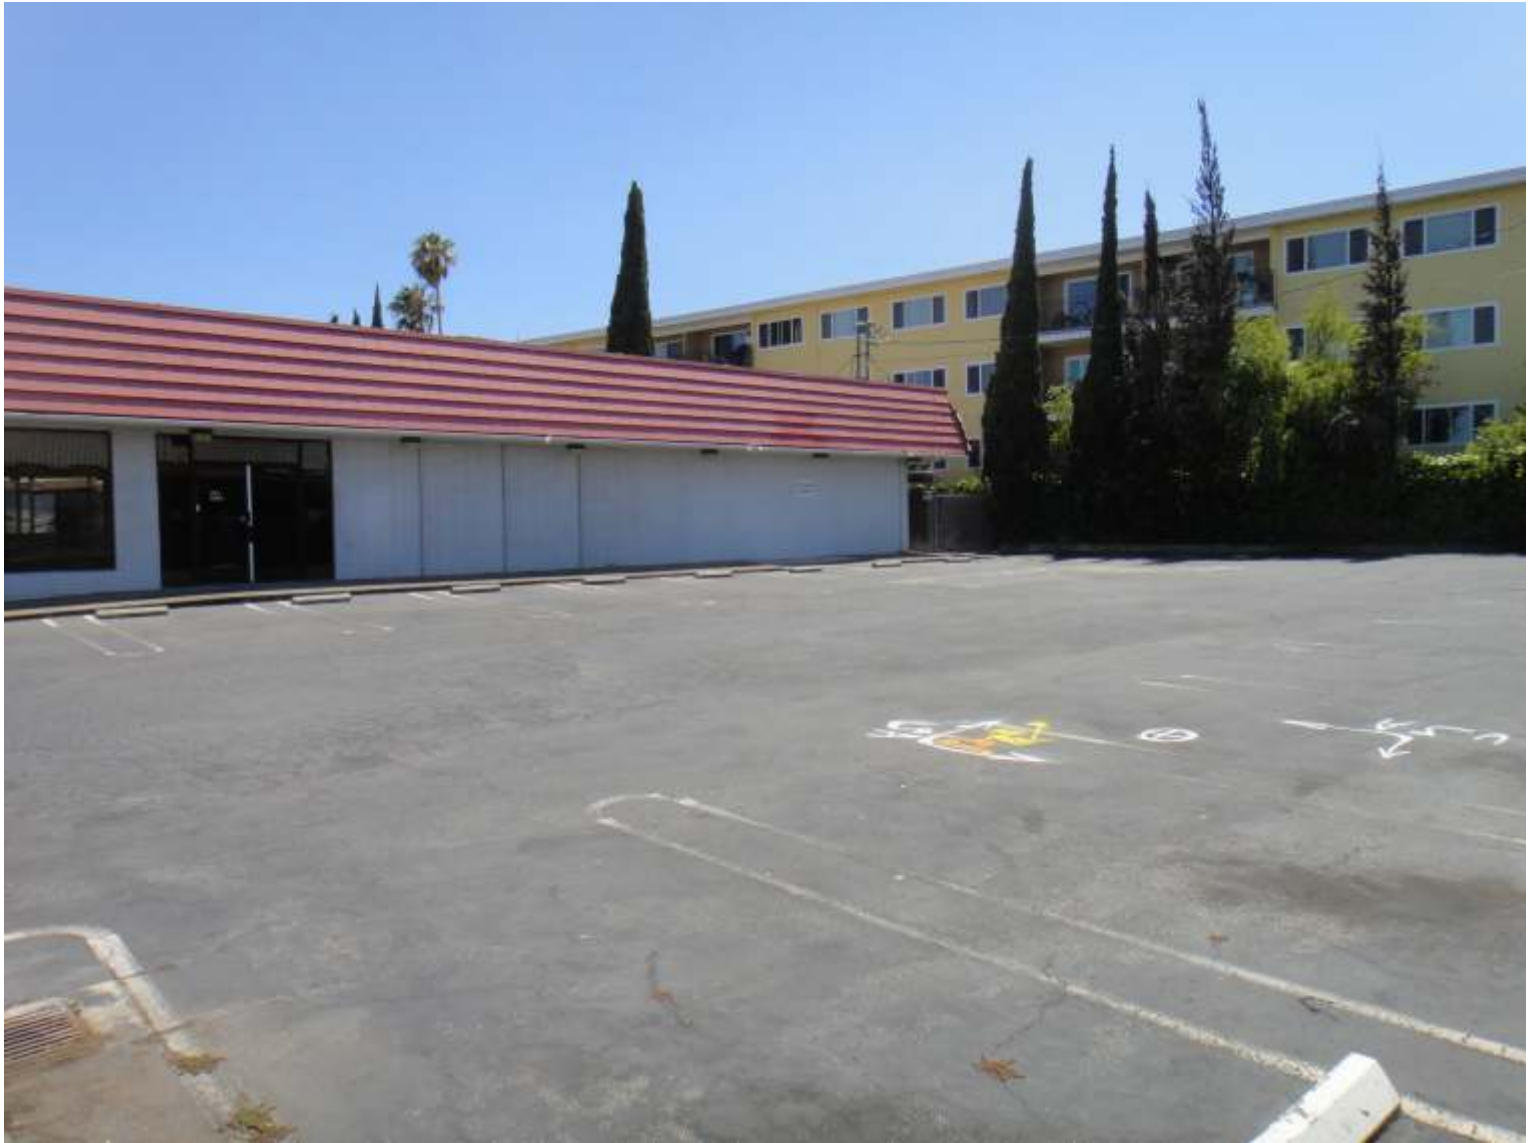
Photo 2 - Southerly view across 2750 parking lot toward existing building.

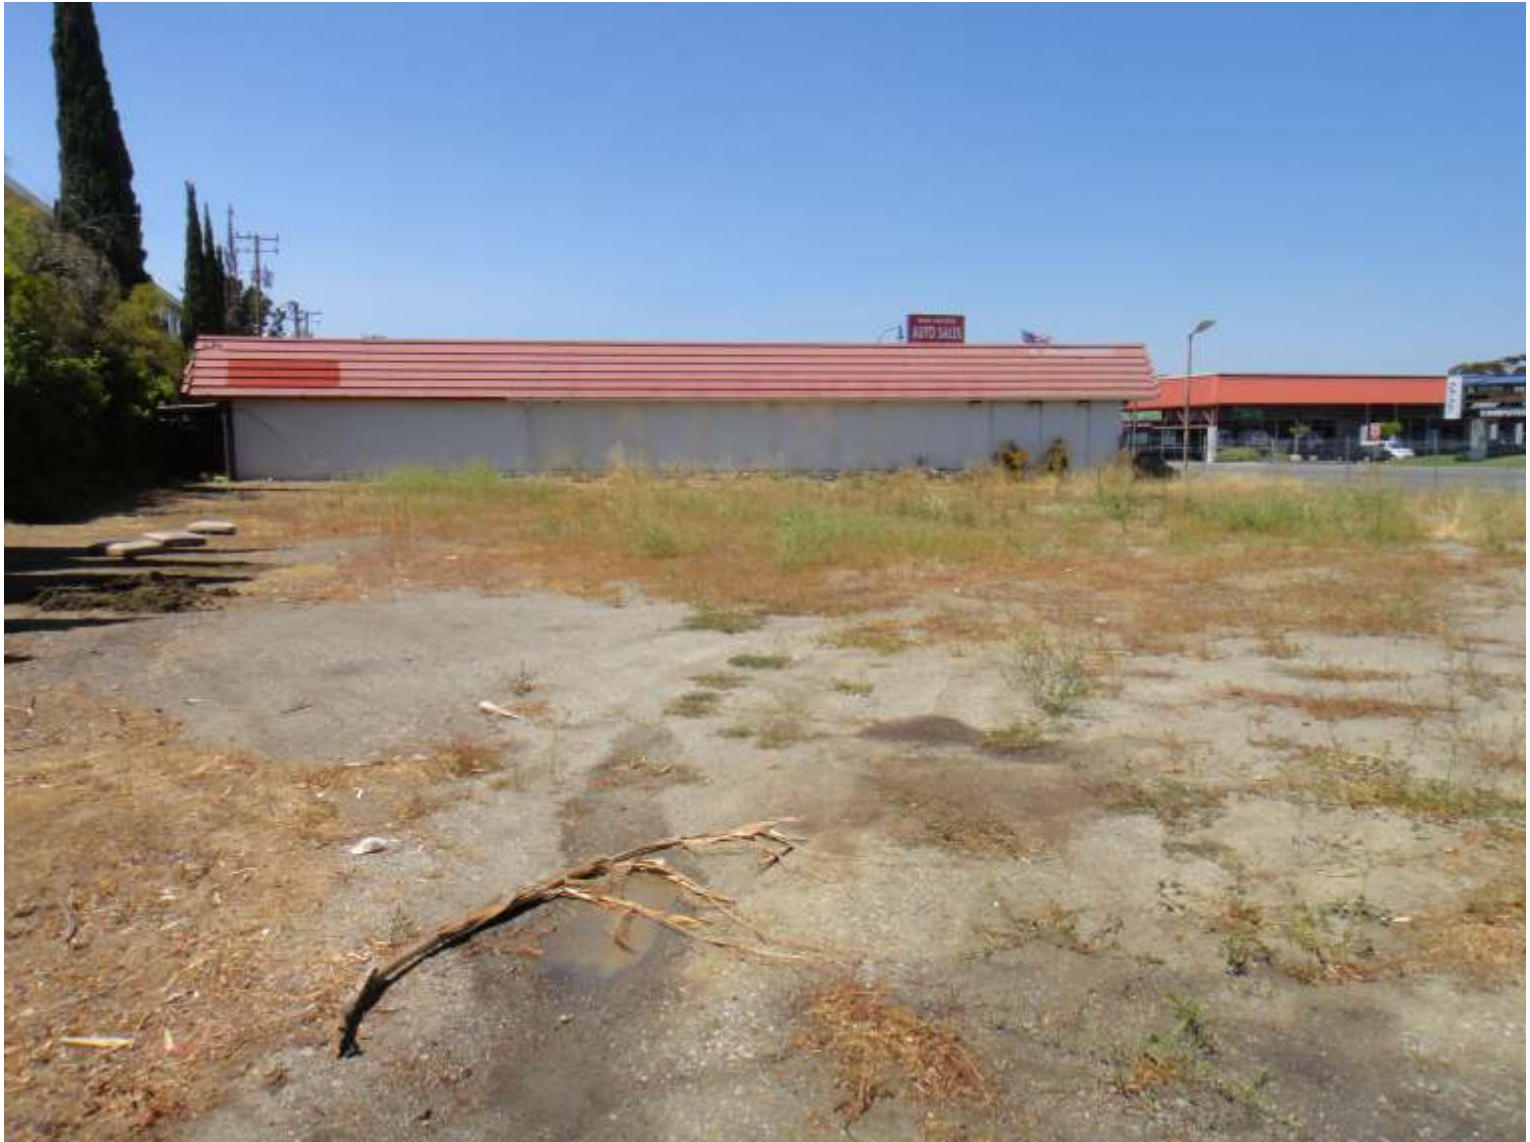
Photo 3 - Northerly view across vacant 2790 (former Texaco service station) toward building on southern side of 2750.

Evidence of the former service station was not detected during our site investigation, however the limited data provided in the environmental report you submitted indicate virtually the entire site was excavated during closure of the service station (Plate 2). Soils exposed on the surface the southern third of the site were silt and clayey sand with gravel, fill. There was visible evidence of the late 1990's – early 2000's excavations.

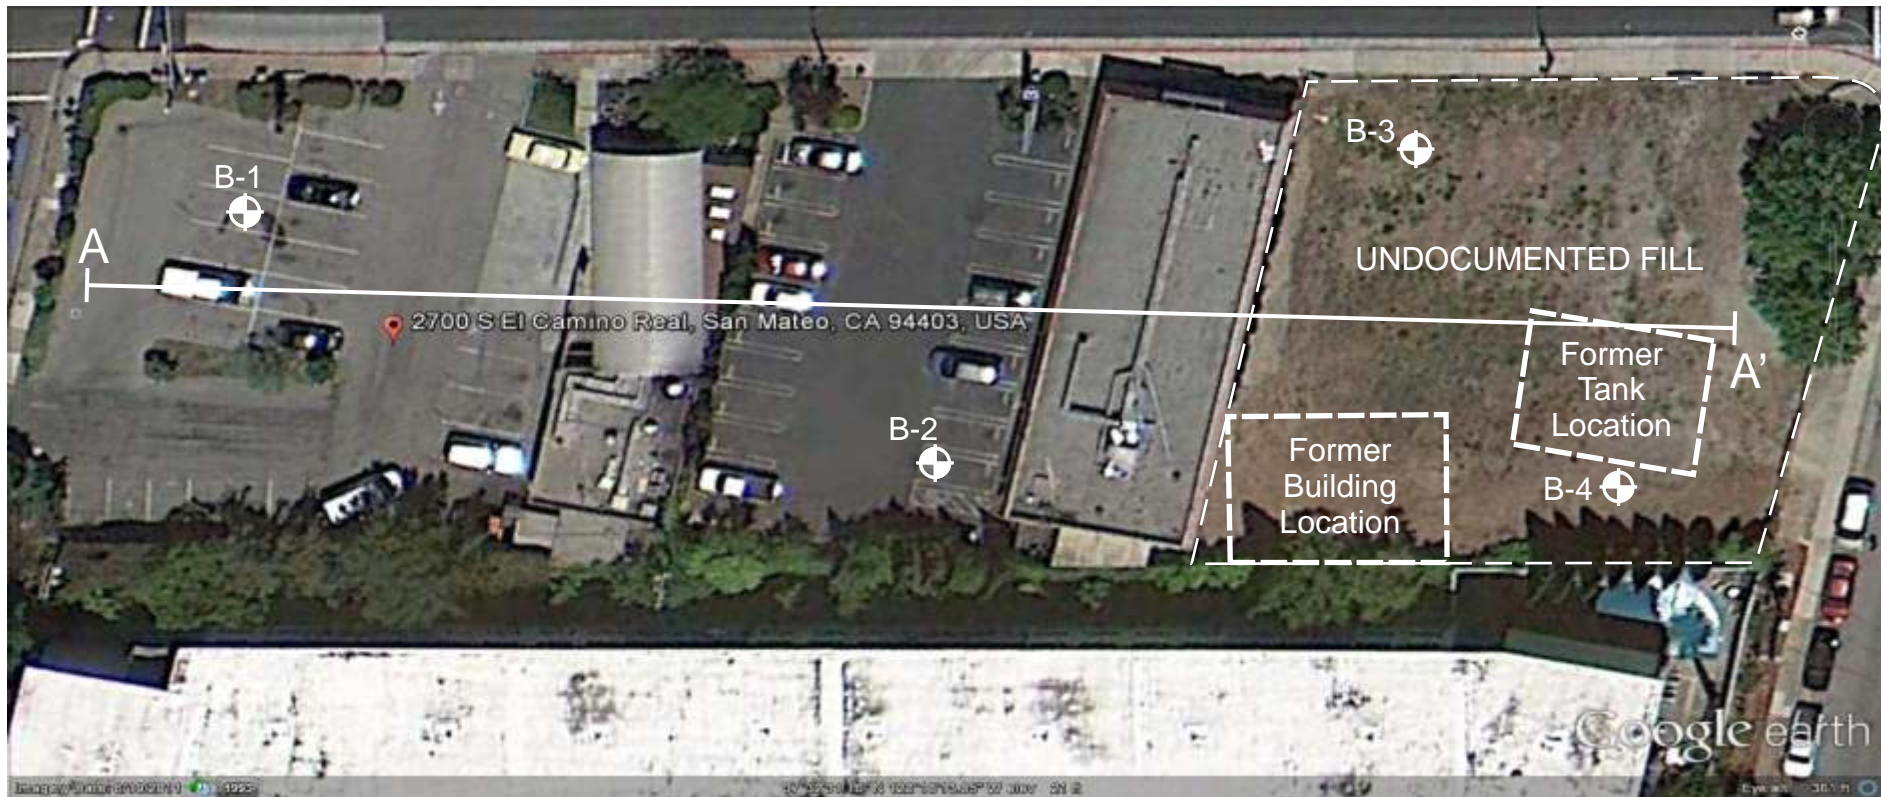
SITE AERIAL VIEW

- 1) Aerial view from Google Earth (2011)
- 2) Site profile inferred from site observations

GENERALIZED CROSS SECTION A-A'

SITE AERIAL VIEW &
GENERALIZED CROSS SECTION A-A'
2700-2790 S. El Camino Real
San Mateo, California

- Site observations and advancement of four (4) truck-mounted hollow-stem auger borings on July 19, 2013 at the locations depicted on Plate 2 (Site Aerial View & Generalized Cross Section A-A'). The borings were supervised, logged and sampled by our field engineer. Logs of the borings are on Plates 4-7. Descriptions of the terms and symbols on the logs is contained on Plate 8;
- Laboratory testing of selected samples from the borings. Moisture content, dry density, pocket penetrometer unconfined compressive strength, and torvane shear strengths of selected samples are tabulated on the boring logs at the respective sample depths. Atterberg limit test results and percent passing the #200 ASTM sieve are contained on Plate 9;
- Analysis of the data and preparation of pertinent geotechnical recommendations for the proposed project. A representative soil profile is contained on Plate 2.
